The first 30 years of Lefkara Dam

K. Kyrrou MSc, PhD, CEng, MICE, A. Penman DSc, CEng, FICE and C. Artemis MSc, DIC, CEng, MICE

The 74 m high Lefkara embankment dam was built in the early 1970s for the Republic of Cyprus Water Development Department in order to supply domestic water to the cities of Famagusta and Larnaca. It is a rockfill dam with a central clay core composed of a combination of residual soils and colluvium supported by diabase rockfill shoulders. The dam was well instrumented using total pressure cells, piezometers and internal settlement gauges as well as surface settlement markers. These instruments are still working and the results are discussed in the paper. The dam is curved in plan since it was anticipated at the time of its design that the arched plan would help resist the thrust from the reservoir, but in reality it made virtually no difference to the behaviour that would be expected from a straight dam. Instead of the conventional vertical valve shaft for housing the water intakes at various levels, a semi-buried inclined gallery (shaft) has been adopted. Leakages of reservoir water through the gallery joints into the gallery have been creating problems

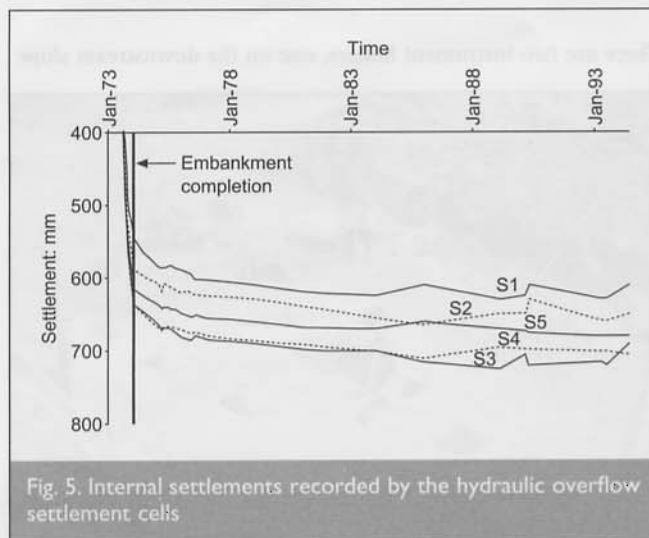
Fig. 5. Internal settlements recorded by the hydraulic overflow settlement cells

Internal embankment settlements have been recorded by the five hydraulic overflow settlement cells installed just below mid-height at the max section (B) as shown in Fig. 4. These instruments performed well during the first ten years of their operation but subsequently great effort was needed to ensure that the three tubes connected to the cells were sufficiently clear to ensure that air pressure in the cells was atmospheric. The most probable cause of these problems was blockage of the drain tubes by growth of algae. Readings were obtained up until 1994 (i.e., for more than 21 years) when these instruments were abandoned. The instruments have nevertheless recorded the development of settlements during this period accurately, as shown in Fig. 5.

width of the core (S_3). This maximum settlement was of the order of 720 mm and out of this about 600 mm occurred during construction and about 120 mm after completion of the construction works. The average post-construction settlements recorded by the three cells installed in the clay core (i.e. S_2 , S_3 and S_4) was of the order of 80 mm. Although two of the instruments (S_1 and S_5) were installed in the rockfill and the remaining three in the clay core, settlements were of comparable magnitudes and demonstrate a smooth transition between the rockfill and the clay. It is usual for the maximum construction settlements in dams to occur at between one-third and one-half of the embankment height and it seems reasonable to assume that this pattern applied at Lefkara. The settlements recorded by the internal settlement cells at mid-height of the embankment are therefore expected to be very close to the true maximum settlements of the embankment. The magnitude of these settlements is slightly lower than the corresponding settlements from other rockfill dams in Cyprus and this may be attributed to the good quality of rockfill, the effect of sluicing and the high degree of compaction.

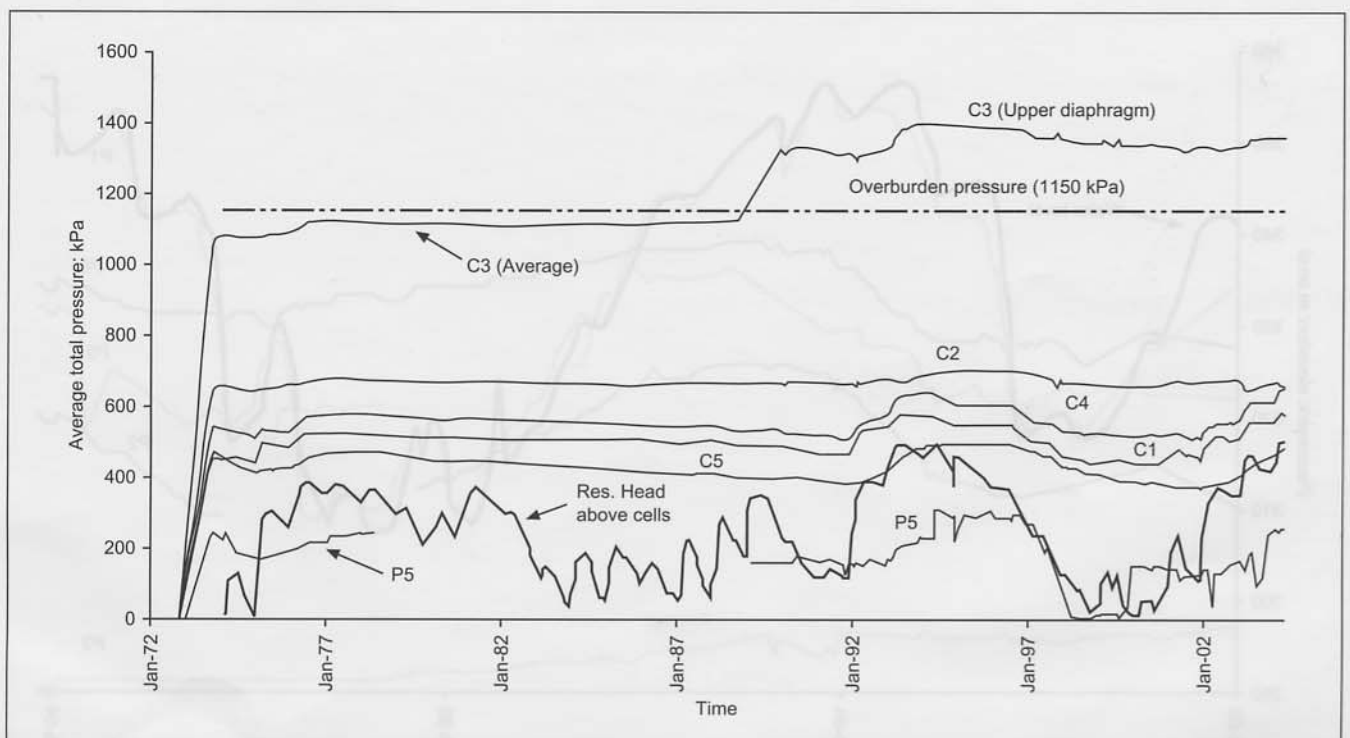
Fig. 12. Variation of average total pressures with time (cluster 1)

In cluster 1 installed at an elevation of 306 m amsl, the highest average pressure is recorded by the horizontal cell (no. 3), followed by the two cells installed at 45° (nos 2 and 4) and then by the vertical cell measuring horizontal pressures in an upstream-downstream direction. The lowest pressures were recorded in a direction along the dam axis (no. 1). Considerable differences have been recorded by the two diaphragms of each cell. These different pressures can be expressed as percentages of the higher measured pressure and these were typically of the order of 4%, 8%, 28%, 38% and 15% for cells 1 to 5, respectively. The horizontal cell (no. 3) and the two inclined cells (nos 2 and 4) have consistently been recording higher pressures on the upper diaphragm. This may be due to the better contact of the fill against the diaphragm which was placed against it, as distinct from the bedding of the lower diaphragm against a prepared surface of the fill that was scraped to be as flat as possible. Although readings are being recorded by all five cells in cluster 1, it was noted that in 1988 the lower diaphragm of cell 3 ceased to record any pressures. Since then only the pressure recorded from the upper diaphragm is being presented and this is indicated by a kink to a higher pressure on the time plot (Fig. 12). The upper diaphragm of cell 2 similarly ceased to operate in February 2003 (more than 30 years after installation) and since then only pressures from the lower diaphragm are presented.

to be 1150 kN/m^2 . The average pressure recorded by cell 3 up until 1988 was slightly below this value but the pressures from the upper diaphragm presented thereafter are between 16% and 21% higher than the overburden. Assuming this value is an overestimate and by applying a cell action factor of 1.09 as suggested by Buck,² the corrected pressure given by Fig. 12 is between 8% and 13% higher than the overburden. Because of the expected and measured greater settlement of the core, some transfer of loading from the core to the rockfill shoulders was expected, so that it was concluded that the pressure recorded is in fact an overestimate. On the other hand, there is no need to expect the total pressure to exactly reflect the height of overburden above a particular point in

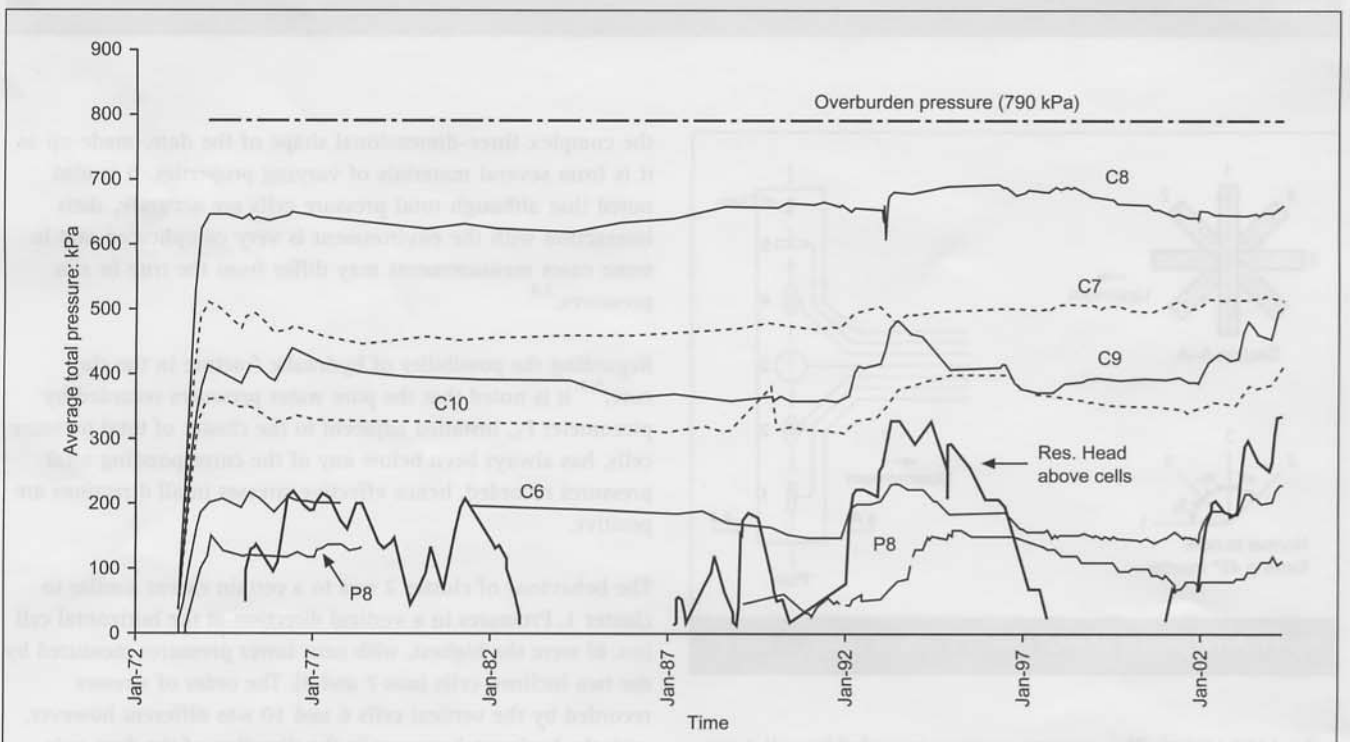
Fig. 13. Variation of average total pressures with time (cluster 2)

The behaviour of cluster 2 was to a certain extent similar to cluster 1. Pressures in a vertical direction at the horizontal cell (no. 8) were the highest, with next lower pressures measured by the two inclined cells (nos 7 and 9). The order of stresses recorded by the vertical cells 6 and 10 was different however, with the horizontal stresses in the direction of the dam axis (no. 10) being higher than those normal to it (no. 6). Evidence of this higher horizontal pressure along the dam axis with its associated compression strains has been observed by arching of kerbing stones at crest level as shown by Fig. 14. As in the case of cluster 1 there were differences between the two diaphragms of the cells, which were typically of the order of 8%, 9%, 18%, 45% and 6% of the higher measured pressures for cells 6 to 10, respectively. Similar to cluster 1, the upper diaphragms also record higher pressures than the lower ones. It is noted that one of the diaphragms of cell 6 ceased to operate in 1995 so the pressure presented thereafter is that recorded by the remaining diaphragm.

At the location of cluster 2 the overburden has been estimated to be 790 kN/m^2 and the vertical pressure recorded by cell 8 is between 80% and 87% of this value. Despite the high horizontal pressure, a more acute arching action at this position may have carried some of the overburden weight. Comparing the pore-water pressures recorded by piezometer P_8 and the lowest total horizontal pressures recorded by the cells of cluster 2 it is evident that effective stresses in all directions are positive at all times. The total pressures, shown by Figs 12

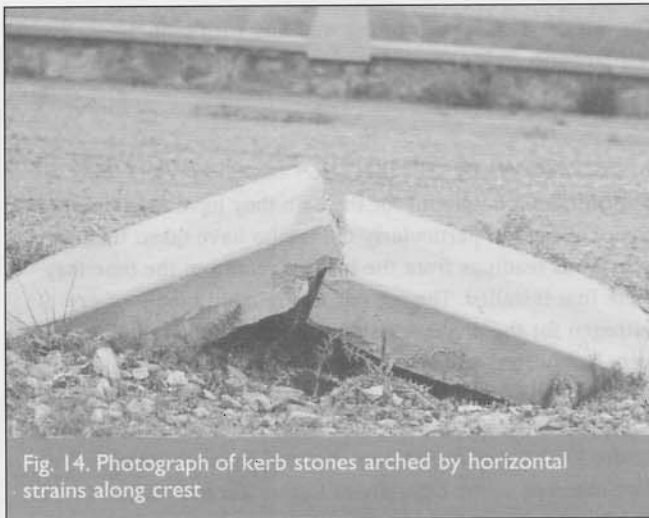
Fig. 14. Photograph of kerb stones arched by horizontal strains along crest

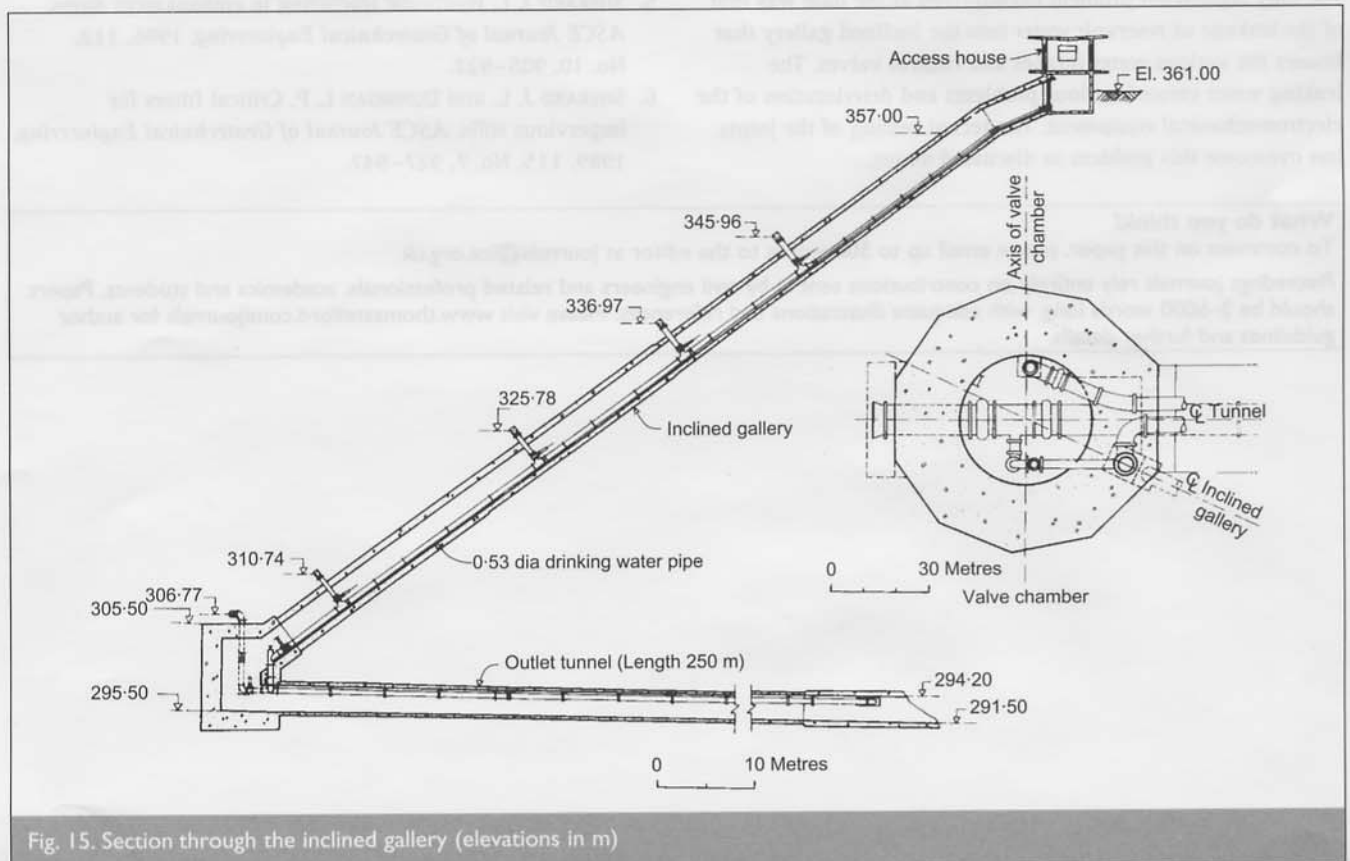
Fig. 15. Section through the inclined gallery (elevations in m)

The gallery, shown by Fig. 15, was cast in 6 m long monolithic sections with expansion joints incorporating rubber centre bulb water stops. With the rise of reservoir water it was noticed that some of these joints leaked. Attempts to seal the leakages from

inside the gallery have been unsuccessful for many years especially at the lower elevations where pressure is in excess of 60 m head of water. Sealing the joints from outside seems an impossible task in view of the half-buried nature of the gallery, but recently a new approach has been used whereby small holes are drilled into the side of the joint and a cement grout injected. This method proved successful and the leakage into the gallery is now negligible. This work was carried out at the end of 2003 and movements of the joints may produce some leakage again.

Before the effective work of sealing the joints was carried out, the flow of water inside the gallery created numerous problems which included access difficulties, danger from electric shock, deterioration of electromechanical equipment, accelerated corrosion etc.
