# Innovative methods for the Kannaviou CFRD in Cyprus

## Demos Antoniou

Water Development Department  
Government of Cyprus  
Nicosia  
Cyprus  
E-mail: d.antoniou@cytanet.com.cy

# **KANNAVIYOU DAM THE FIRST CFRD IN CYPRUS**

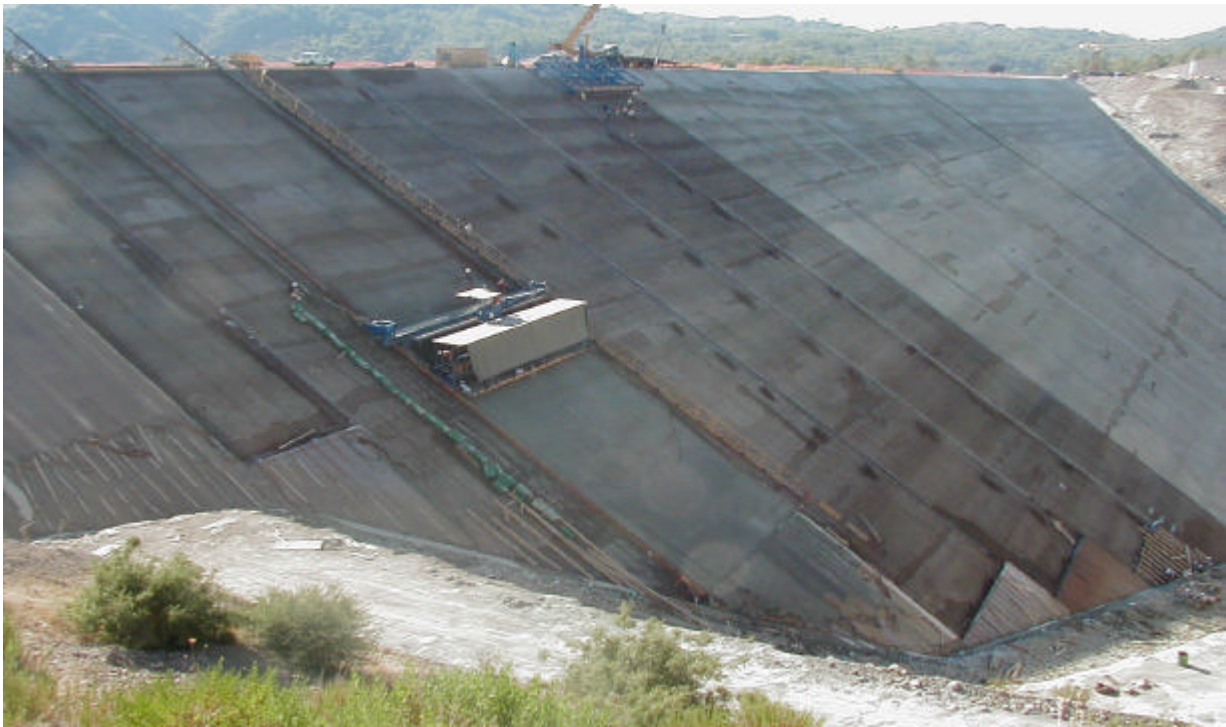
Photo.1 Upstream Face Slab Concreting

Concreting was continuous without stoppage so that a "cold" joint was always avoided along the bay width. The slump of the concrete was carefully controlled to be between 7-9 cm so that the concrete could flow down the side chutes and also to be retained under the top shutter and be compacted well before the shutter moved upwards. The shutter which was the self climbing type split in two halves, was moving up with the use of two hydraulic jacks on either side. The speed of movement originally assumed to be in the range of 2-2.5 metres per hour maximum, was during construction actually averaging 3.6 metres per hour, which is quite high for this type of work. At the bottom end of the shutter four masons were giving the final levelling and shaping of the concrete surface by hand.

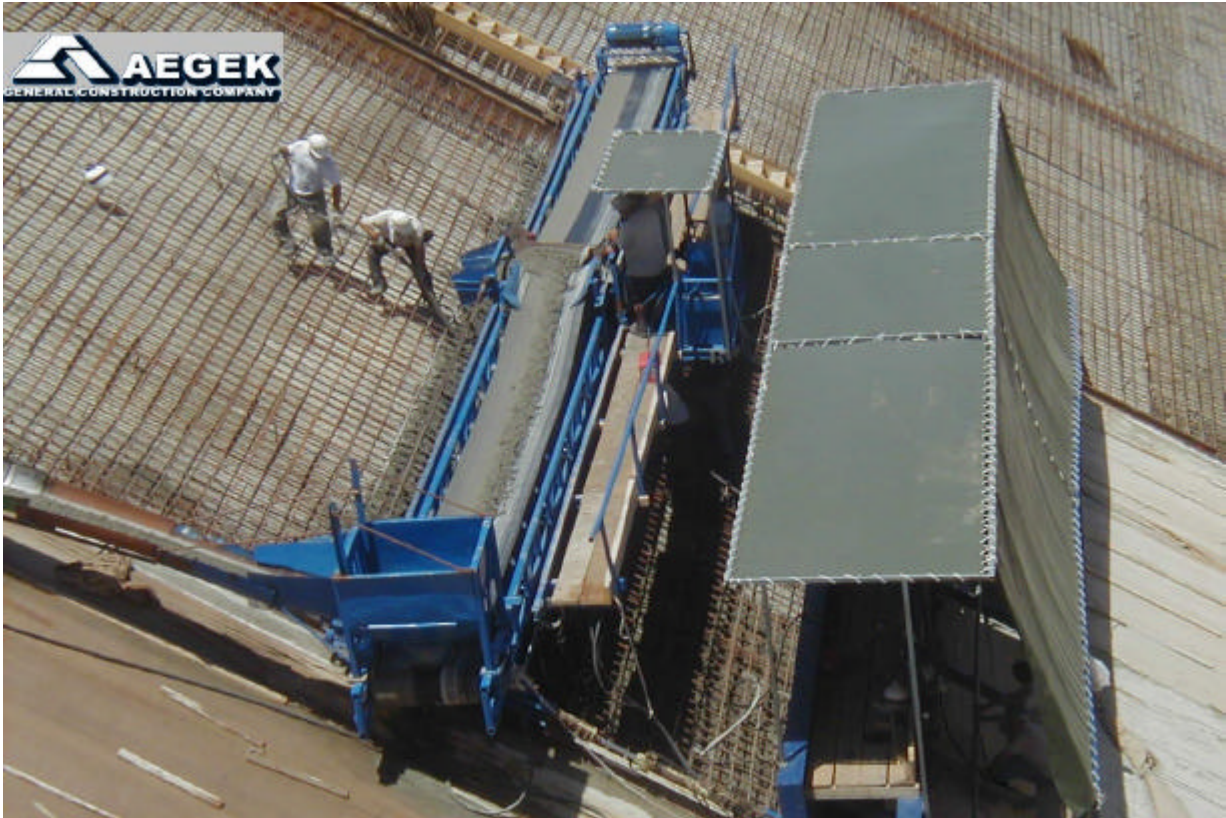
Photo 2. Self climbing slip form with side discharger

The innovative methods employed in the construction of the face slab, with the use of the self climbing top shutter, equipped with a side concrete discharger and a rail system for fast transport along the crest, a custom made trolley for reinforcement installation, produced excellent results and achieved a record of 3.5 m/hour of shutter average speed. The unique method used for testing all of the copper waterstop brazed joints, represent an important milestone in the concrete face dam construction.

- The slabs were casted consecutively, one after the other, so side shutters were placed only on one side of the slabs. Concrete was casted against the previous slab at the other side. The moving shutter was moving on two rail lines, one placed on the top of the shutter and at the other side on the previously casted bay.

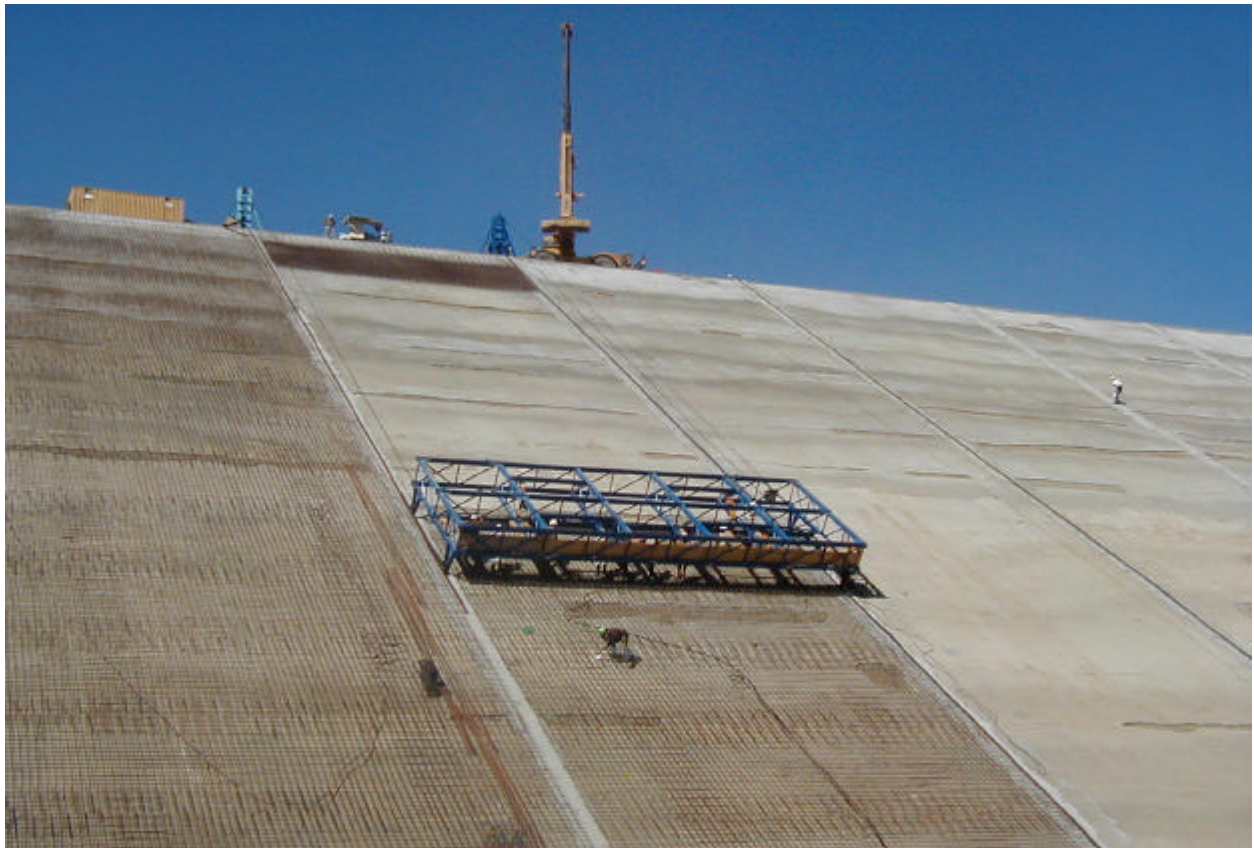
Photo 3. Reinforcement placing trolley

- This operation was followed by the reinforcing mats placing team. These were transported down the face with the use of a trolley travelling on two rail lines. The reinforcing mats were placed in the middle of the slab thickness. The work started from the bottom of the bay and progressed up towards the top of the face.

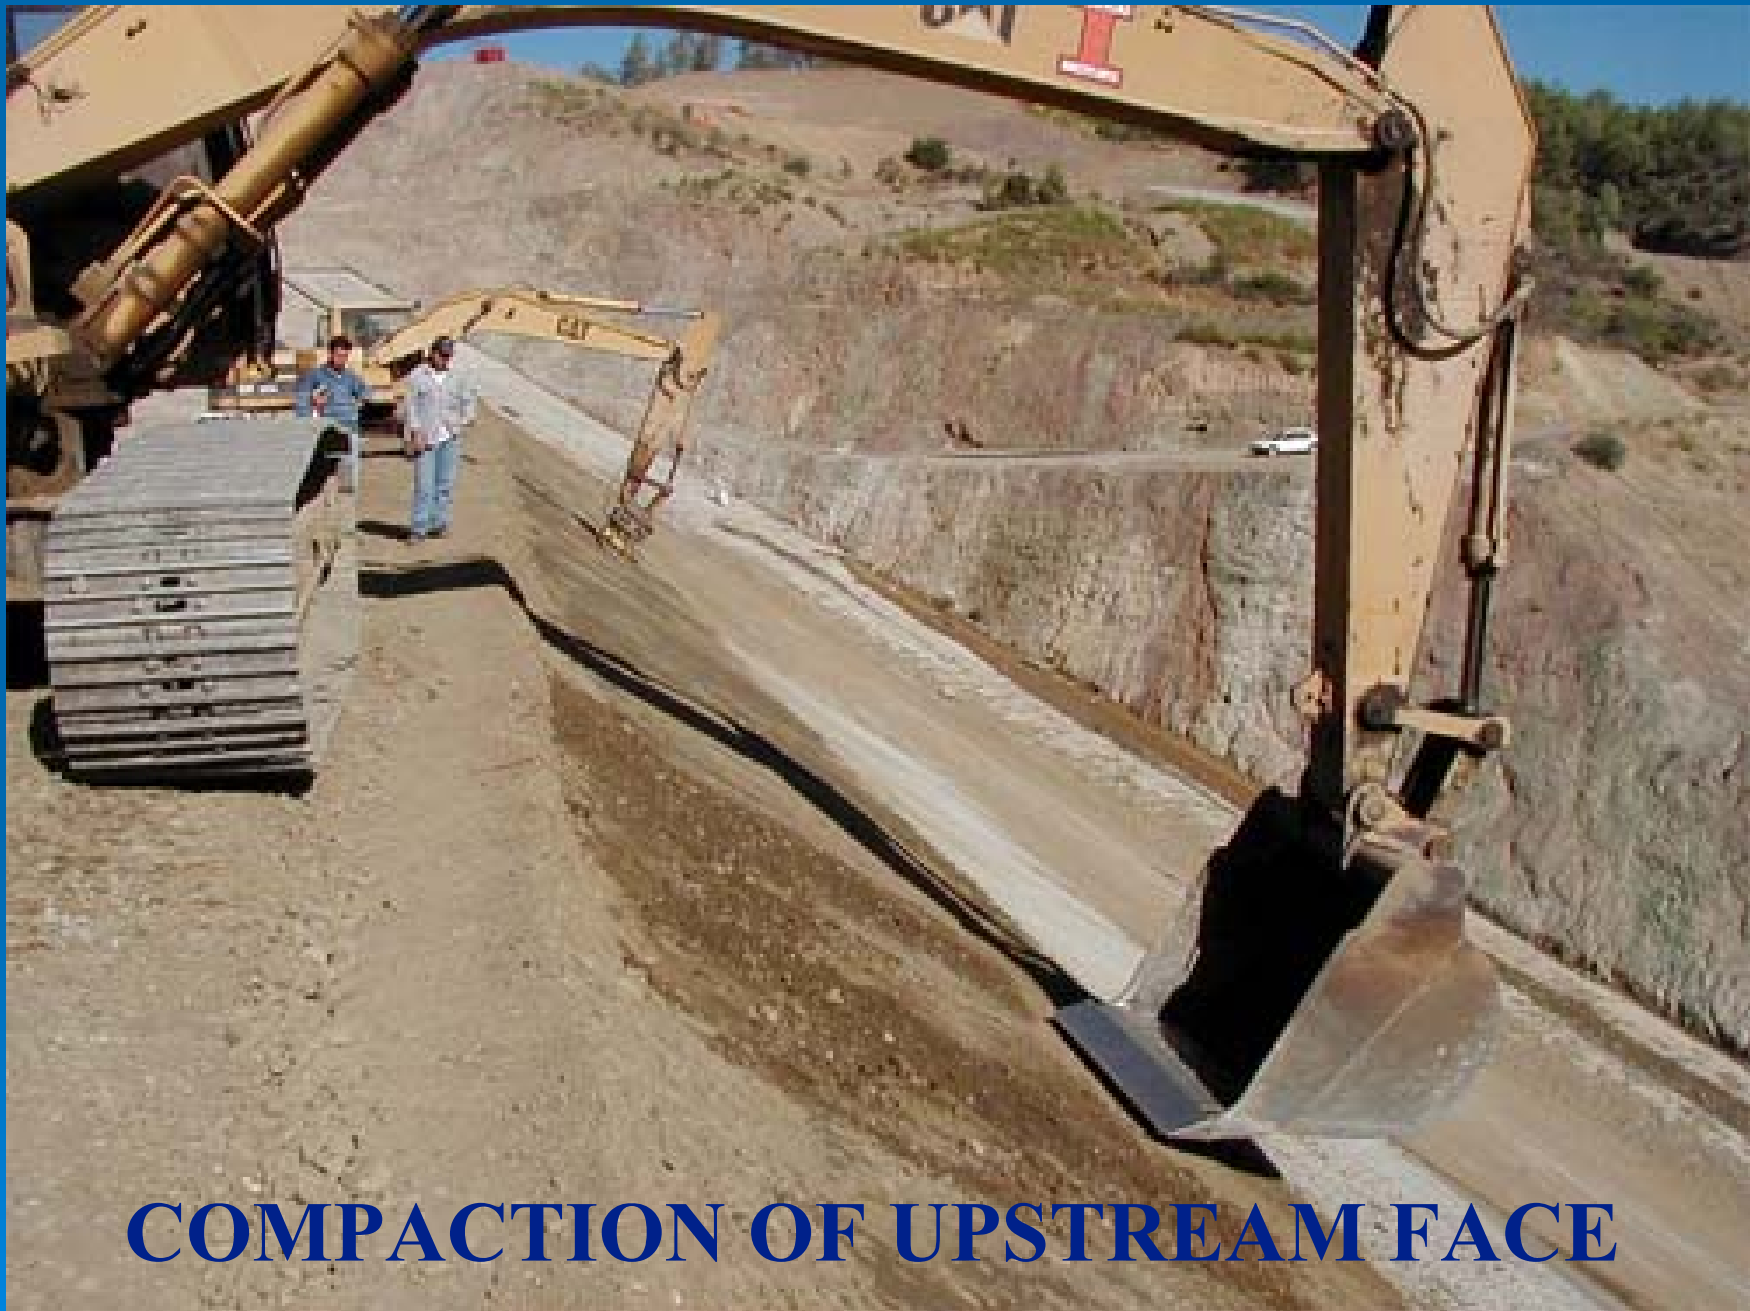
**COMPACTION OF UPSTREAM FACE**

The embankment is divided into materials of zones 2A, 2B, 2C, 3A, 3B, 3C and 3D. Zone 2B, under the upstream slab, has a width of 4.0m. This consists of screened alluvial extracted from the river bed, with maximum size 75 mm and fines up to 8% (63  $\mu$ m). It was compacted in 0.40m layers with 6 passes of 10 tonne vibratory roller. After the removal of the excess material beyond the design line, the compaction of the slope was carried out with 4 passes of a vibrating plate. After the compaction, the slope was protected with a layer of 50 mm shotcrete.

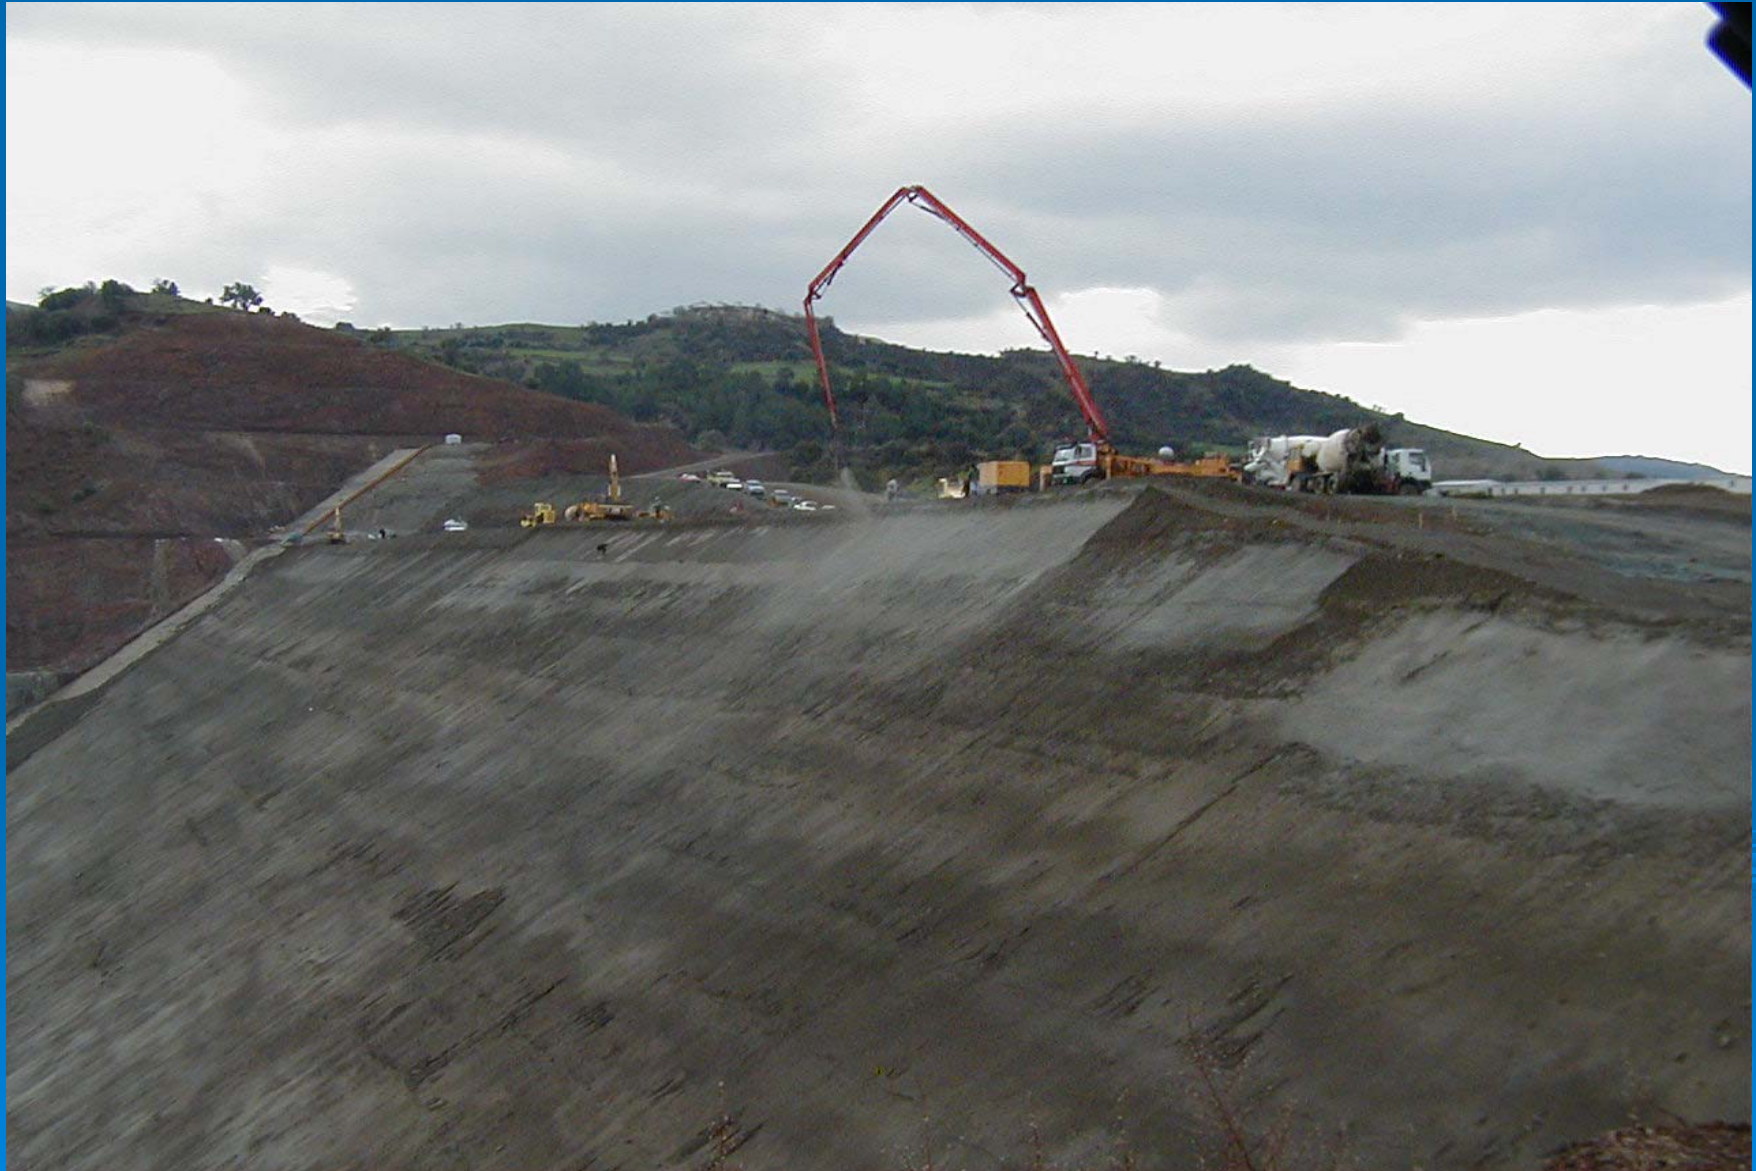
# SHOTCRETING OF U/S FACE

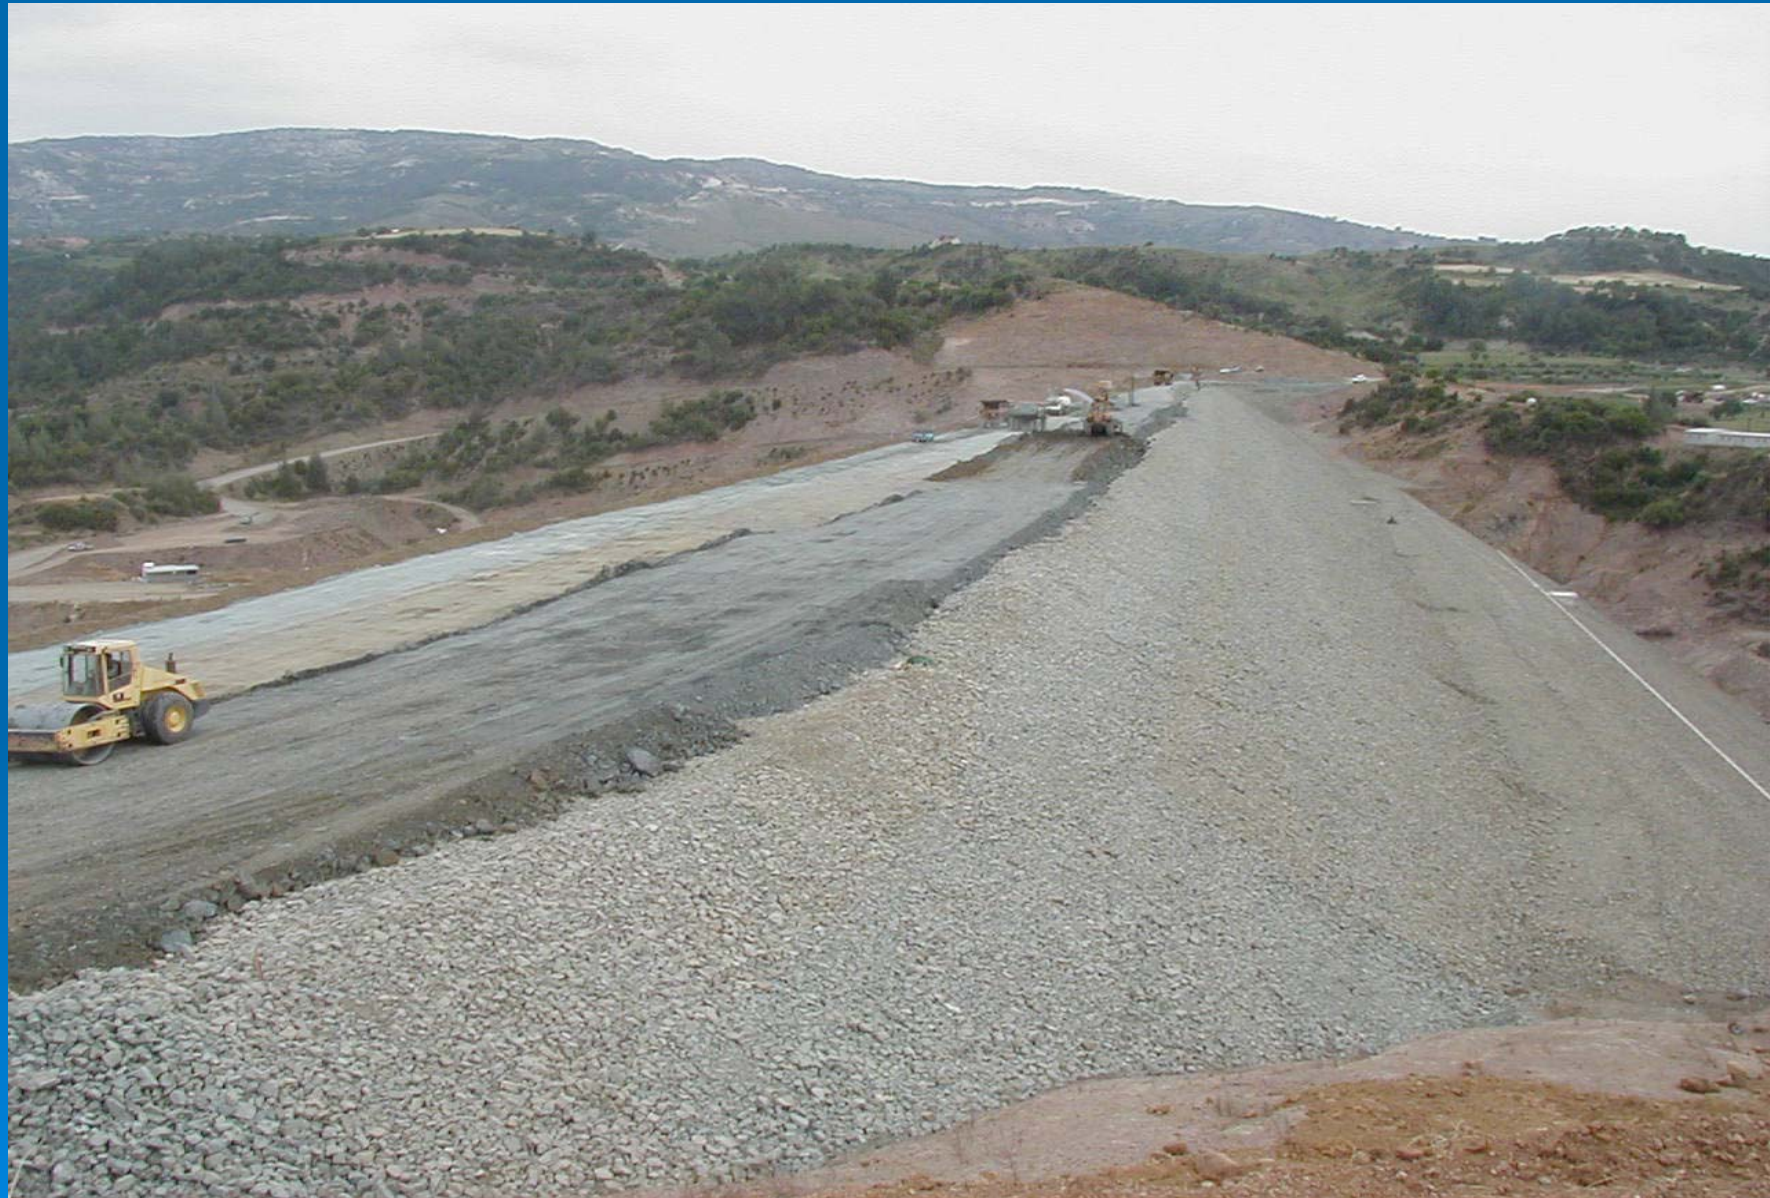
# PLACING OF ZONE 3C

Zone 3C, corresponding to the downstream portion of the dam, was built mostly with pillow lava material produced from the excavations and Quarry B. This rockfill was spread and compacted in 0.5 m layers with water addition up to 12 % and 6 passes of 19 tonne vibratory roller.

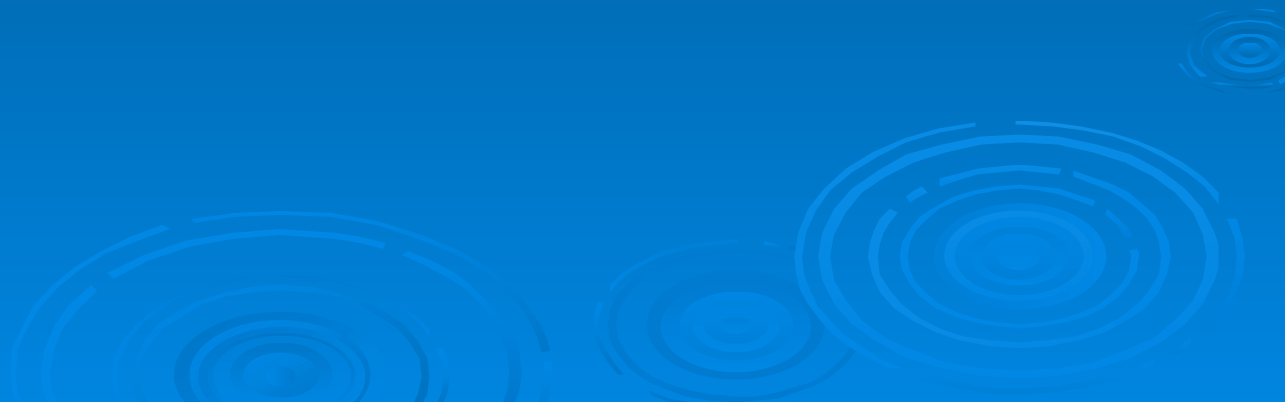
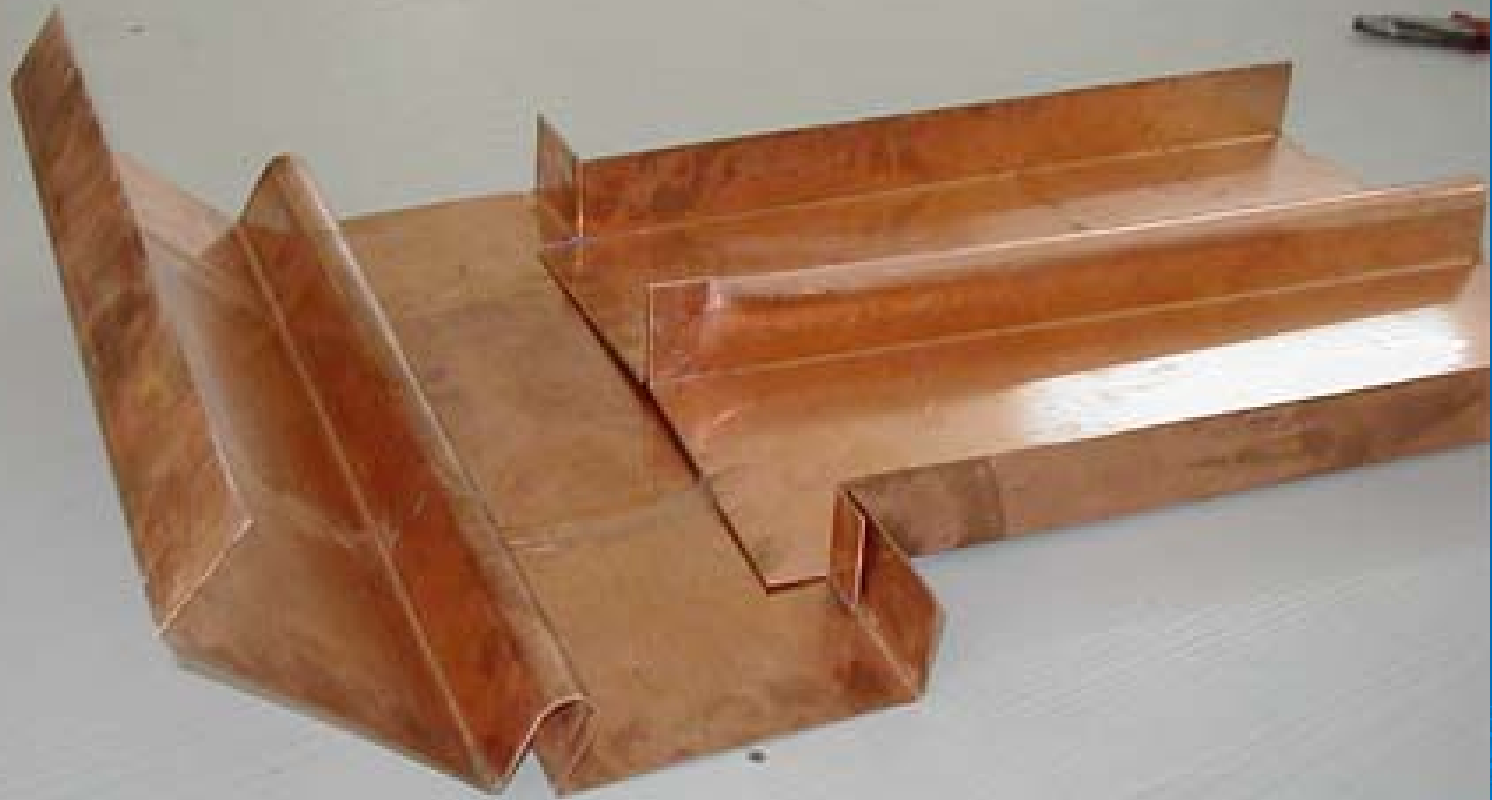
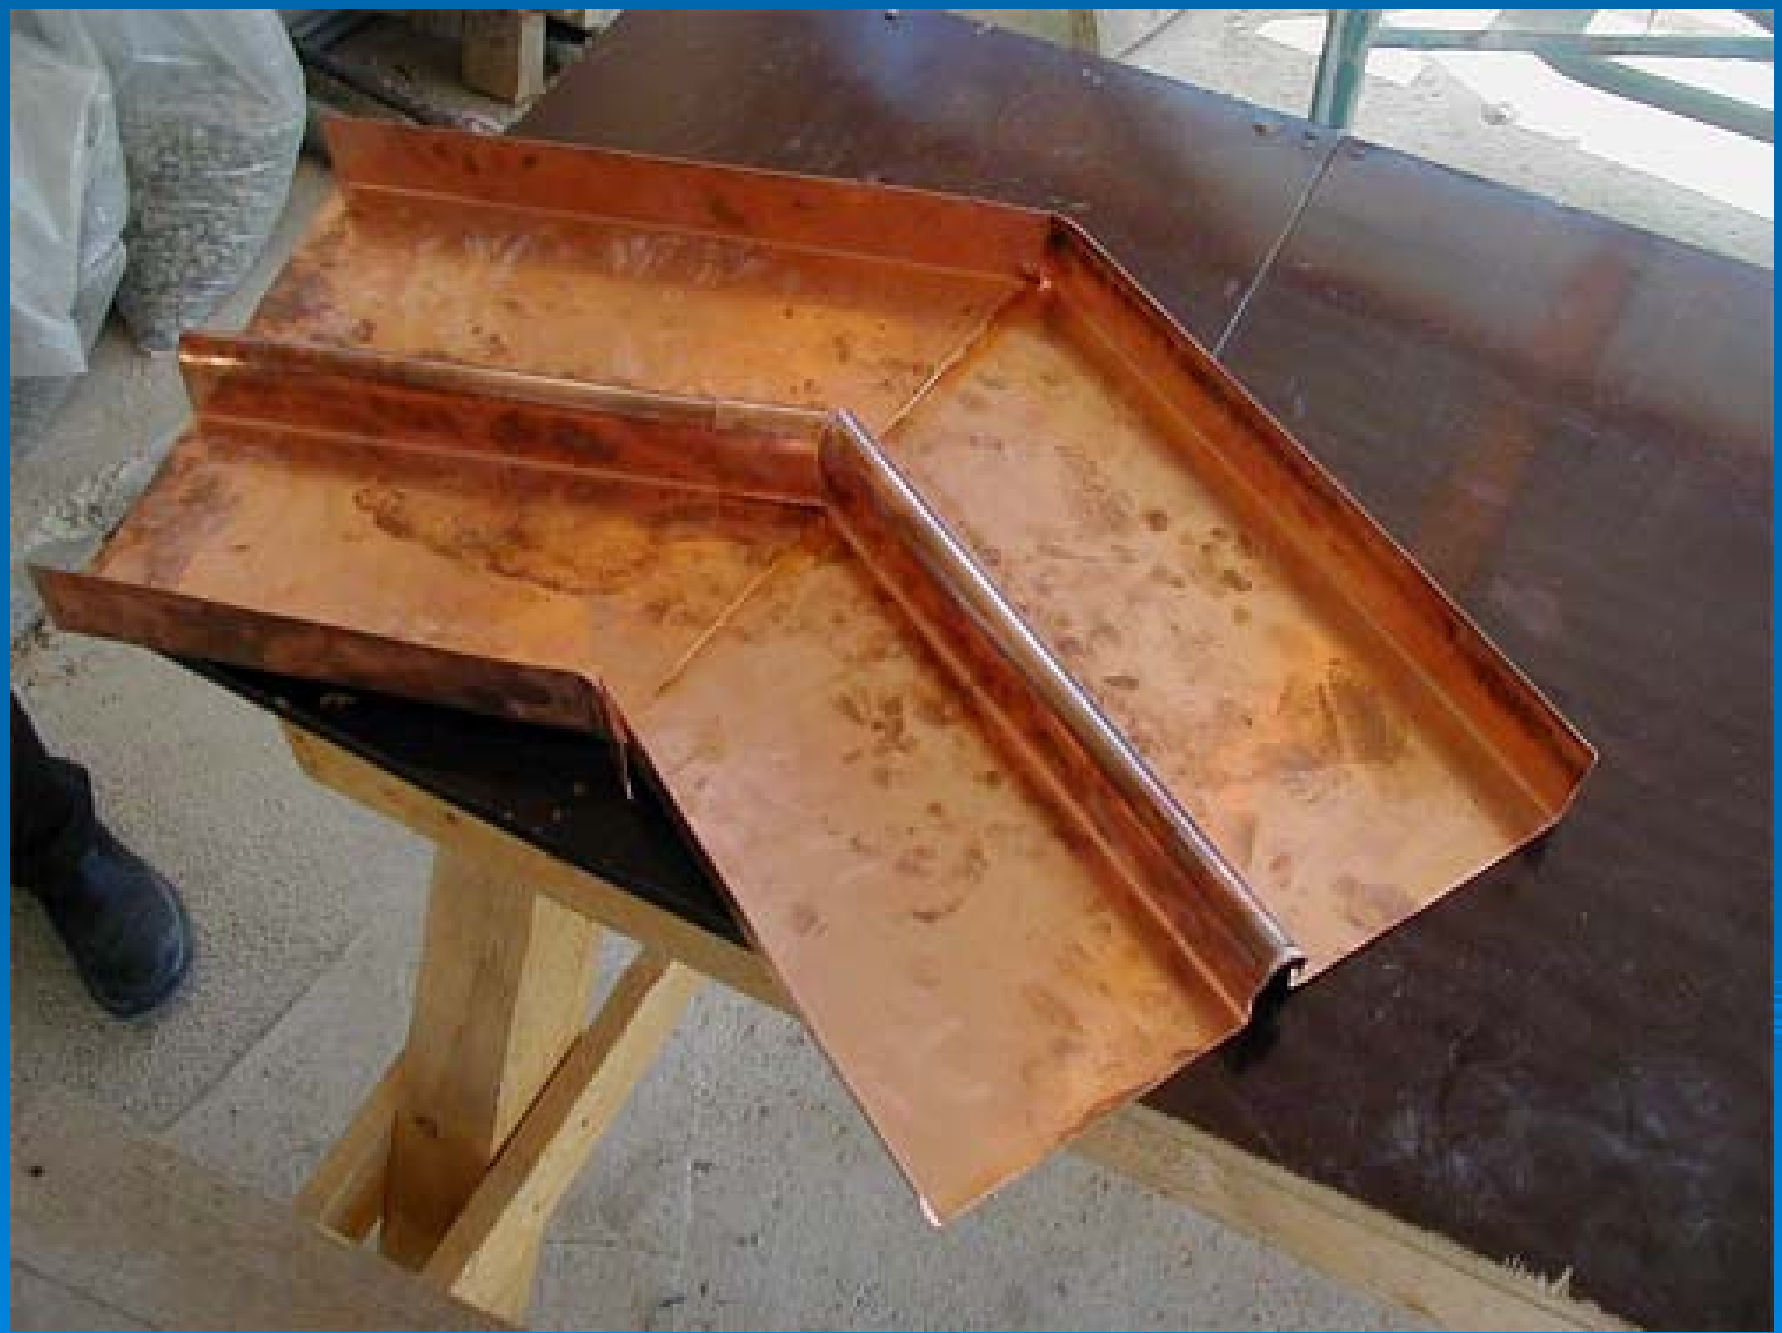
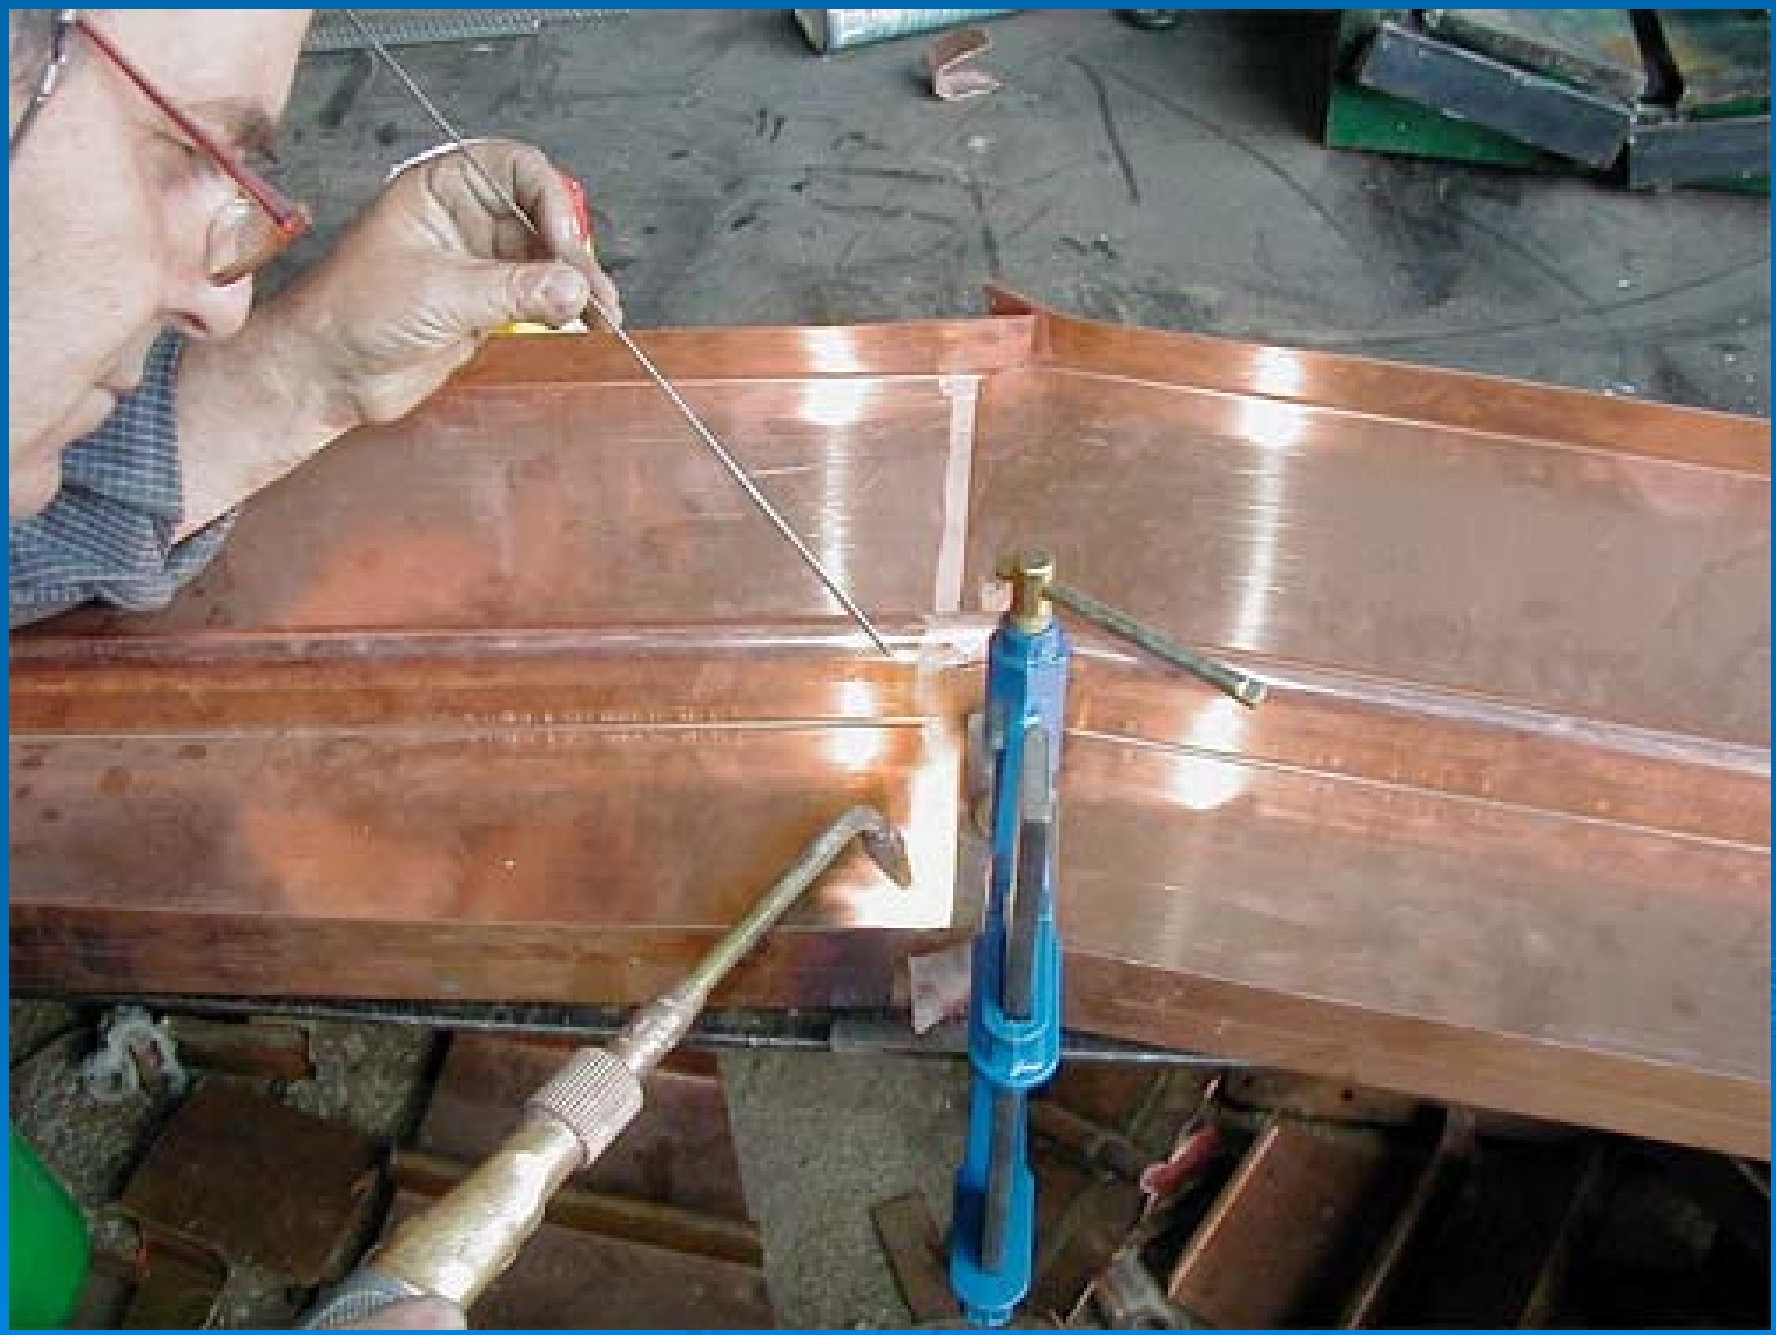
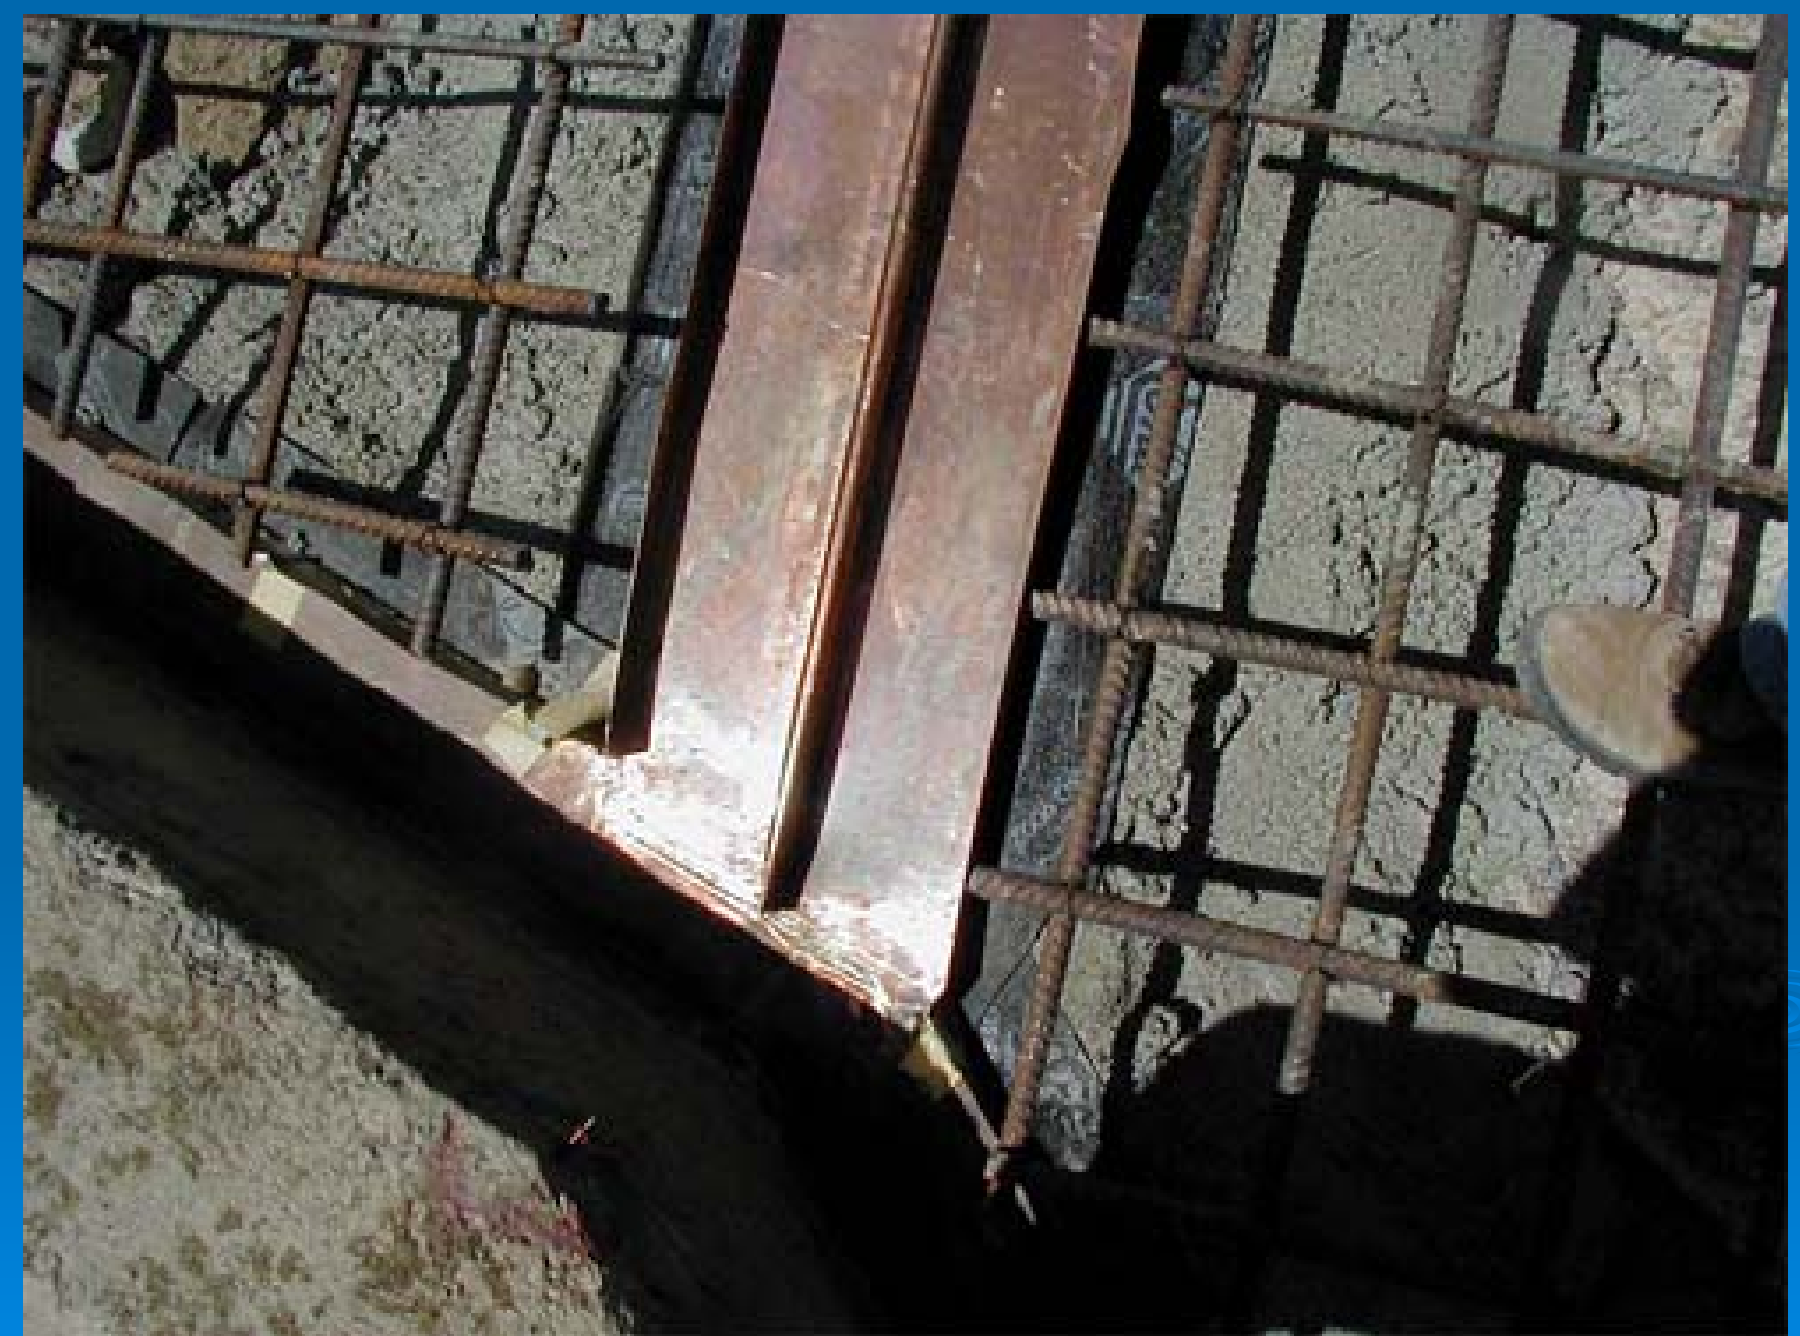
# **BRAZING OF WATERSTOP**

▪ TOTAL LENGTH OF JOINTS	3494m
▪ TOTAL No. OF BRAZINGS	657
▪ No. OF TESTS DONE	657
▪ No. OF FAILURES	11

The copper water stop came in six metres lengths and was placed from the bottom, with the first brazing on the water stop running along the plinth's perimetric joint. All the brazings which were carried out by experienced qualified welders, were carefully visually inspected. A special test apparatus was developed on site, which enable every joint to be tested under vacuum at 0.3 bars. This was proved to be a very effective way of testing the brazings of the copper water stop at every location and configuration of the joint. In total 750 tests were carried out, out of which 10 failures were found which had to be cut out and repeated.
