# Innovative methods for the Kannaviou CFRD in Cyprus

## Demos Antoniou

Water Development Department  
Government of Cyprus  
Nicosia  
Cyprus  
E-mail: d.antoniou@cytanet.com.cy

# **KANNAVIYOU DAM THE FIRST CFRD IN CYPRUS**

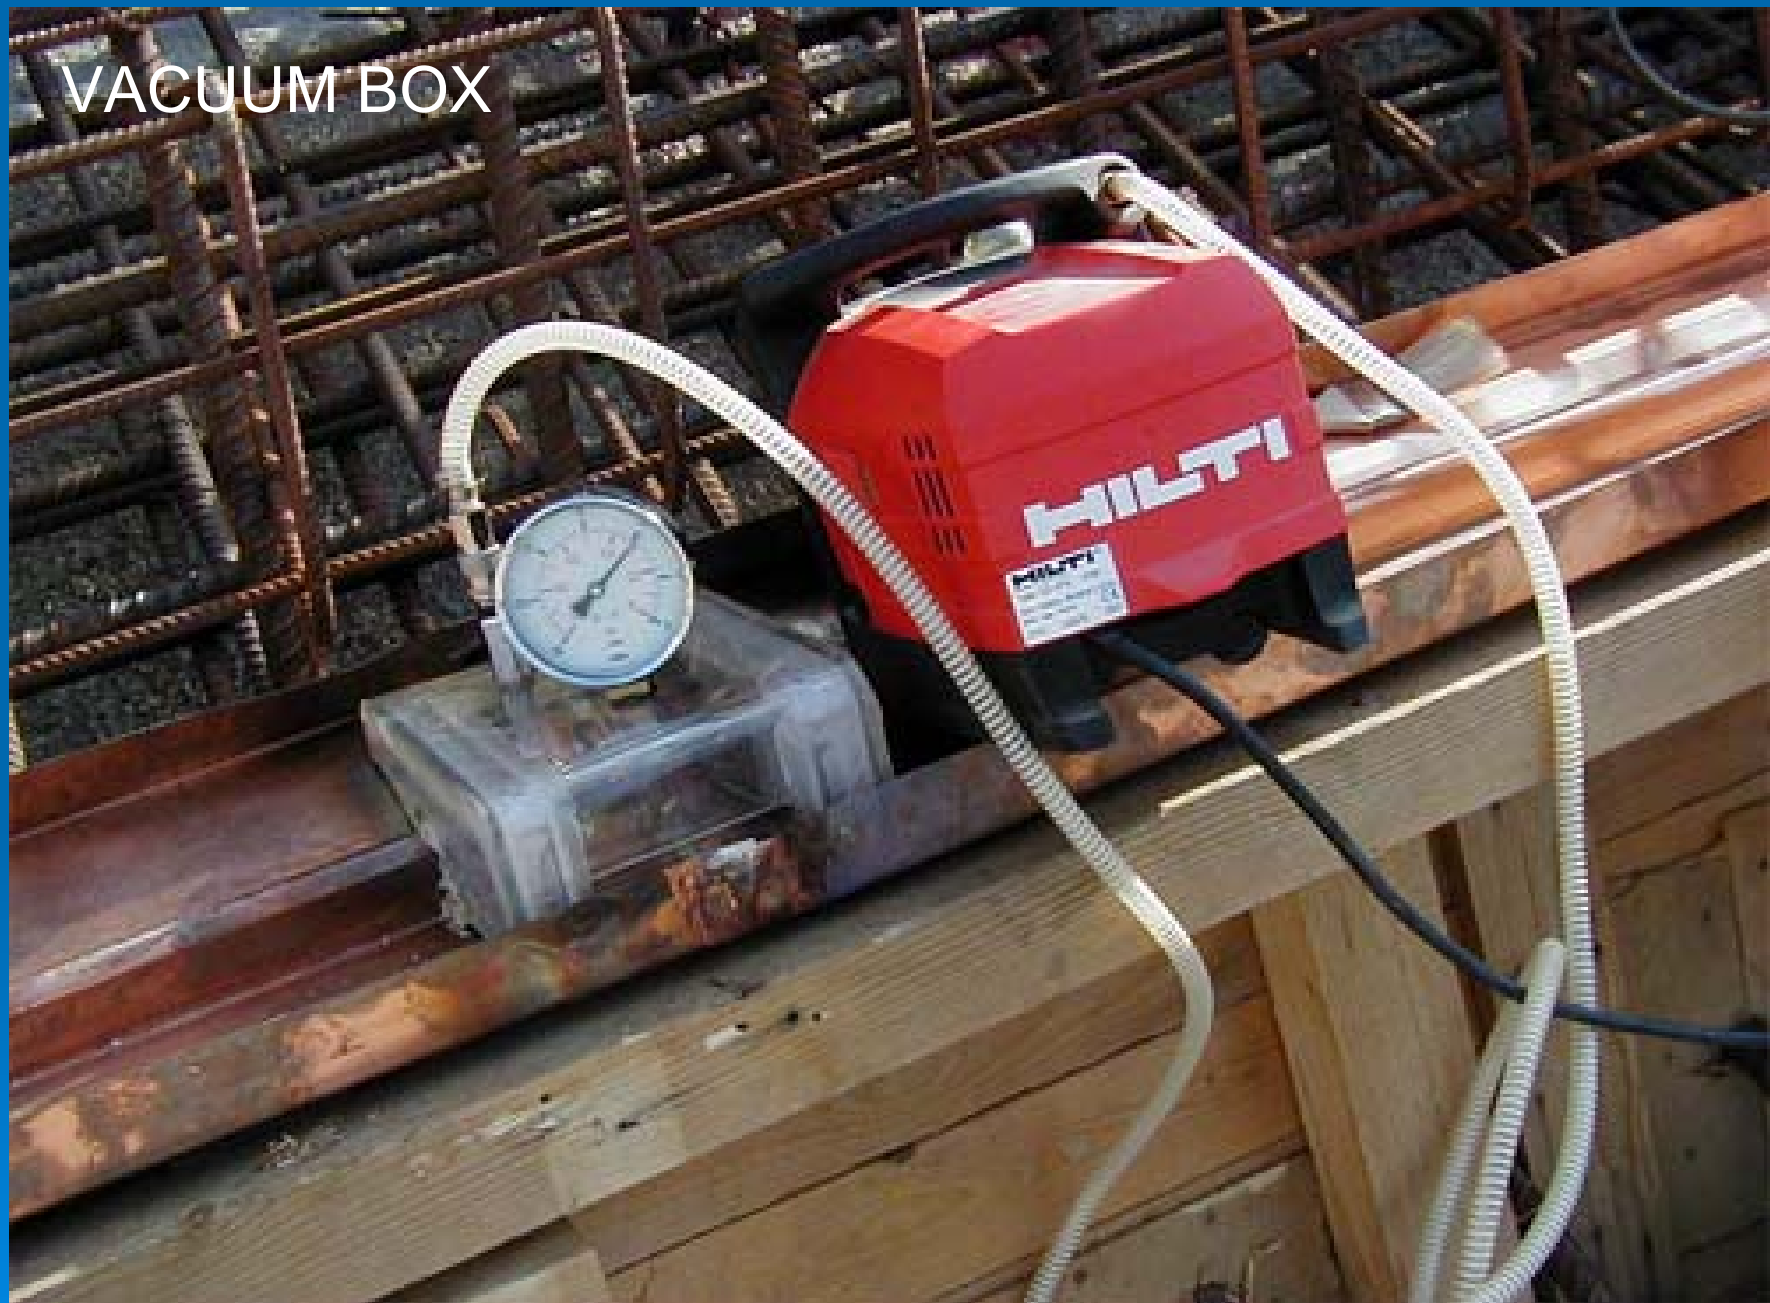
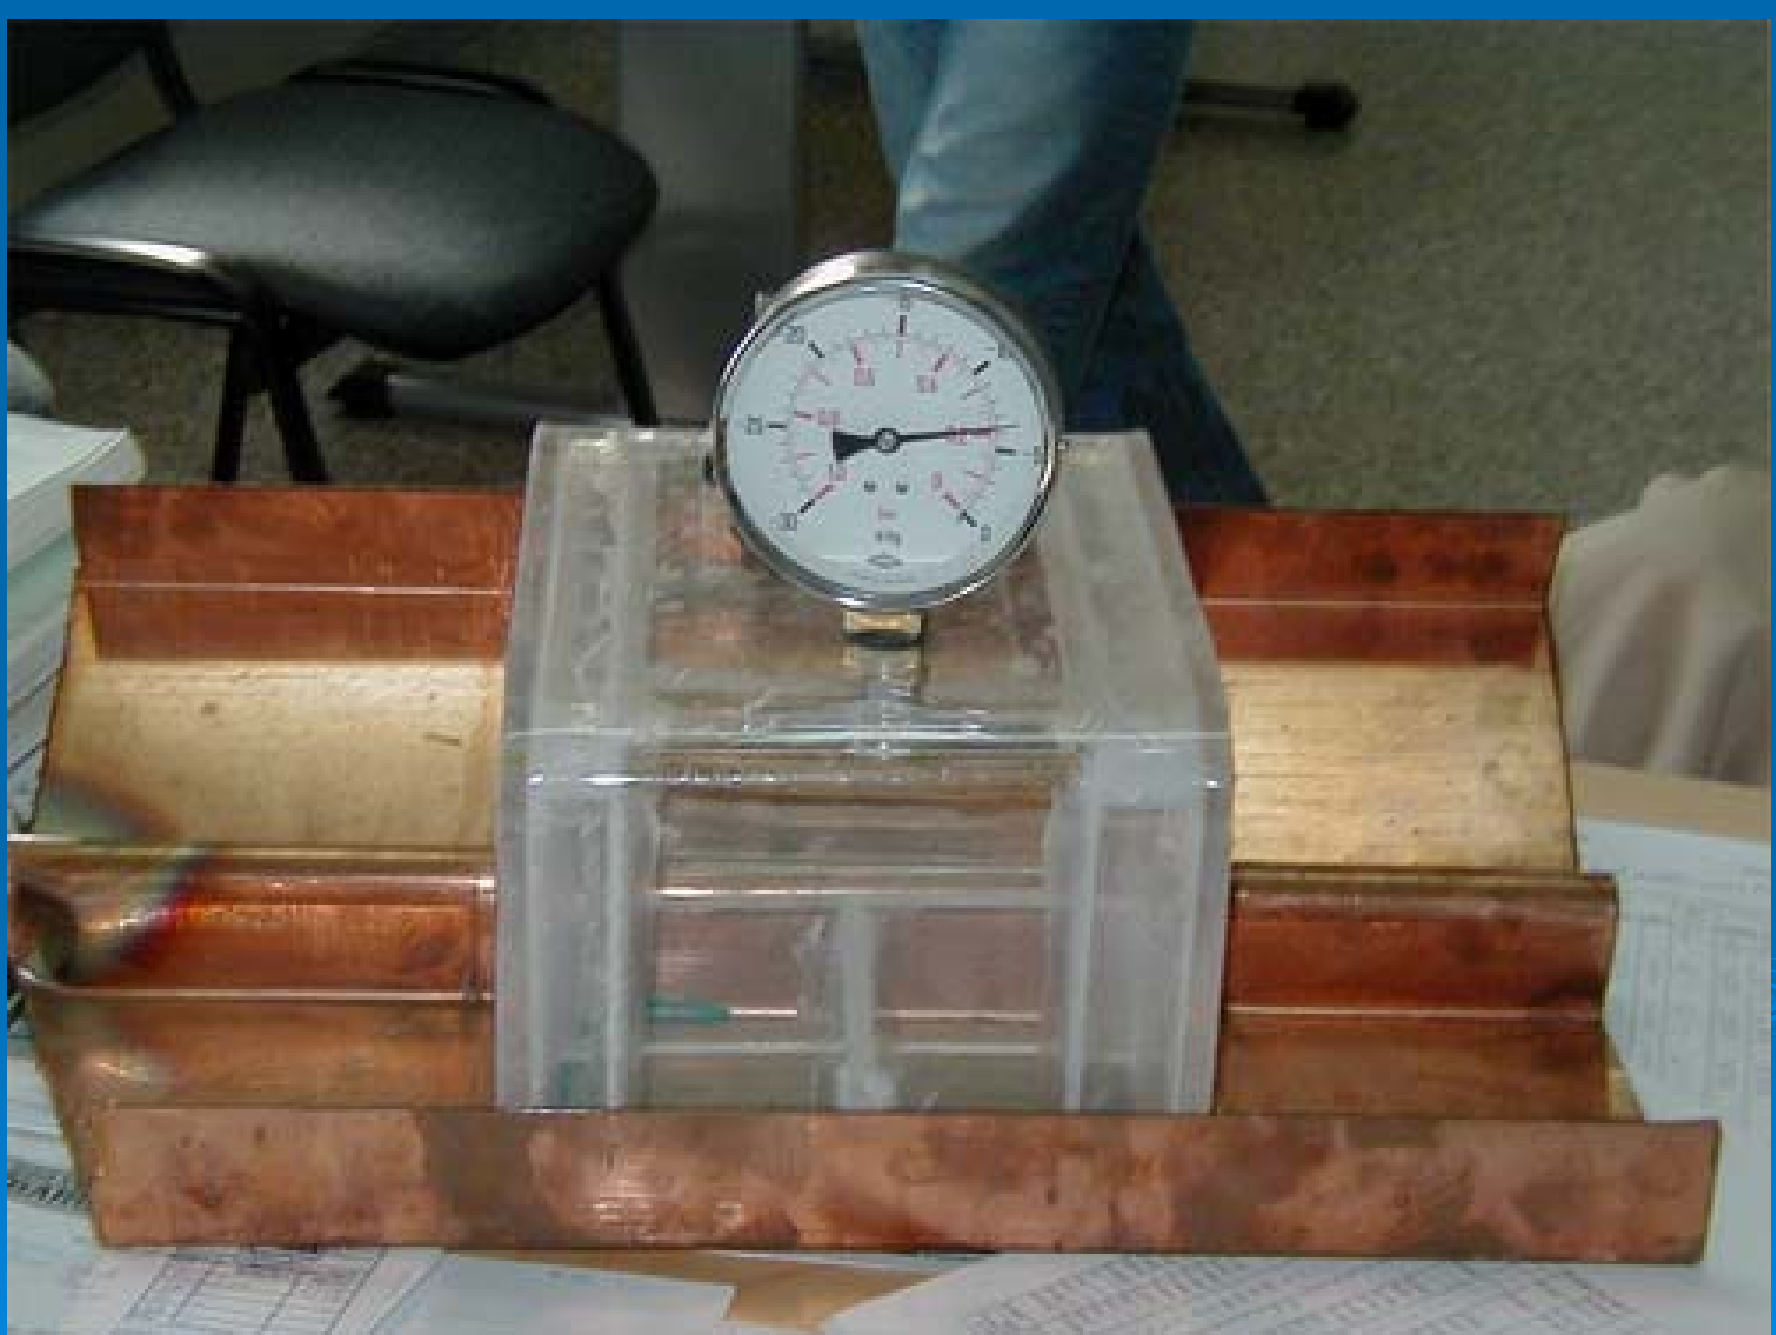
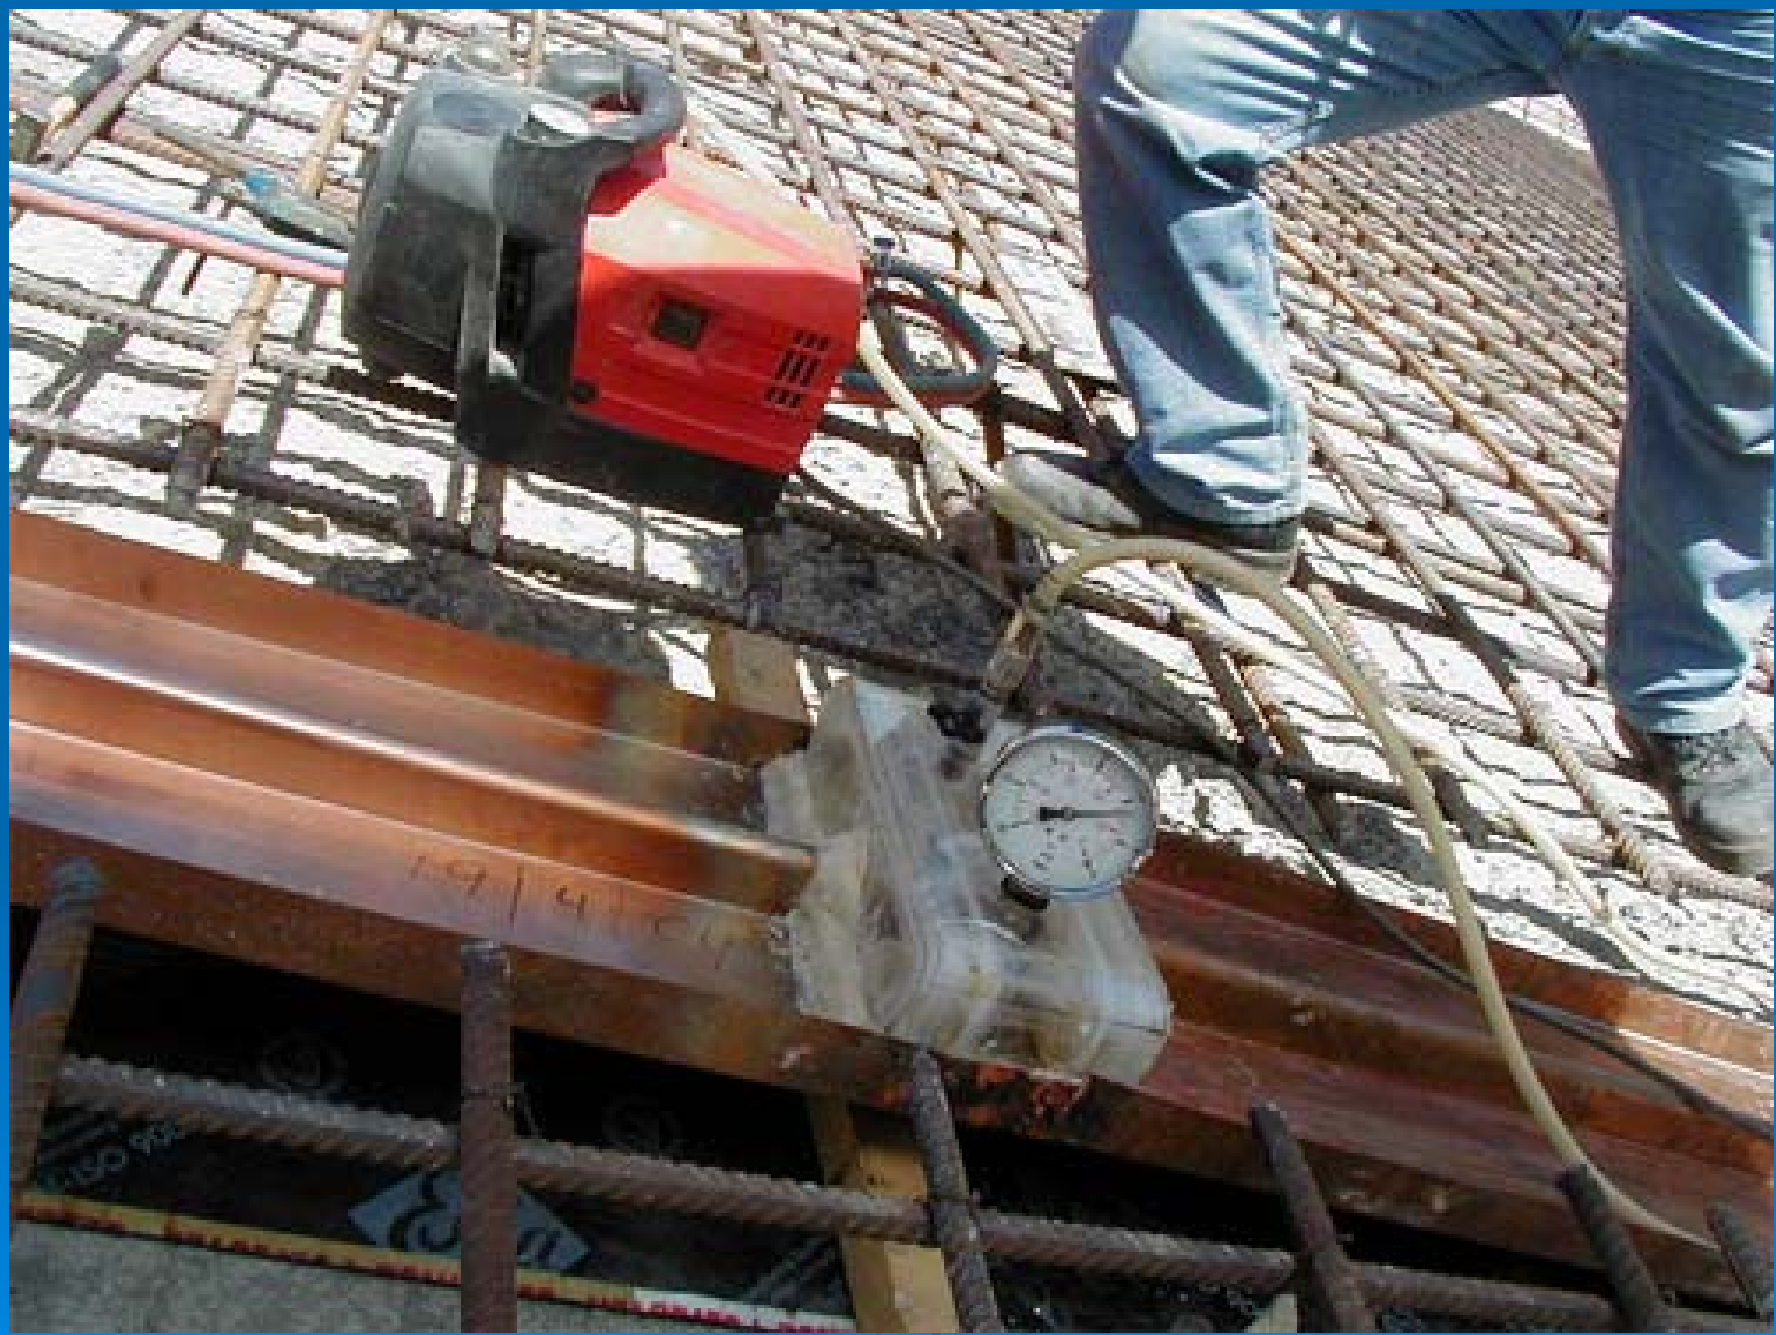
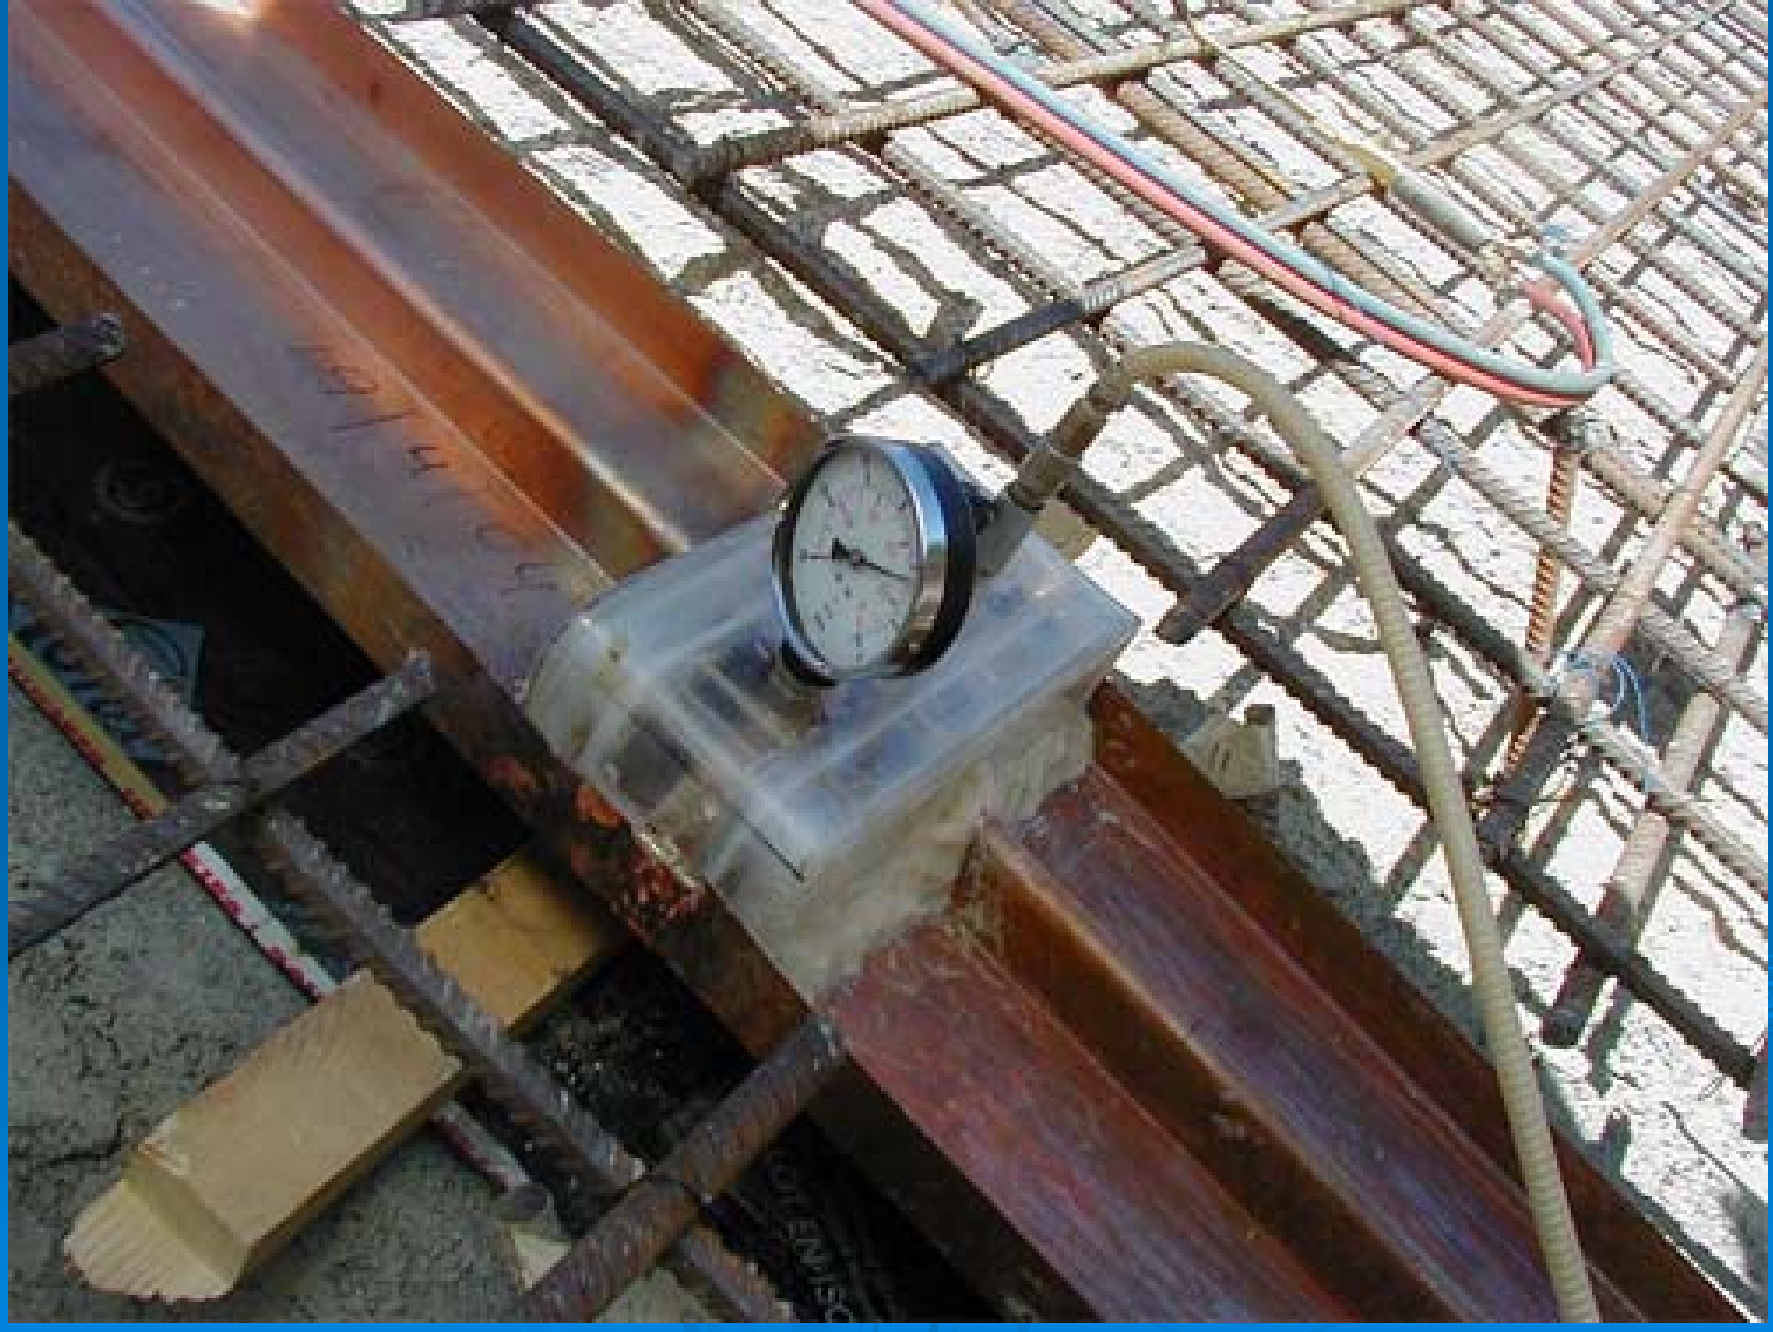
# VACUUM BOX

- VACUUM BOX DEVELOPED ON SITE
- ALL JOINTS TESTED
- VACUUM TEST AT 0.3 BARS VACUUM
- TEST TIME : 20 MINUTES
- FAILURE WHEN PRESSURE DROPS

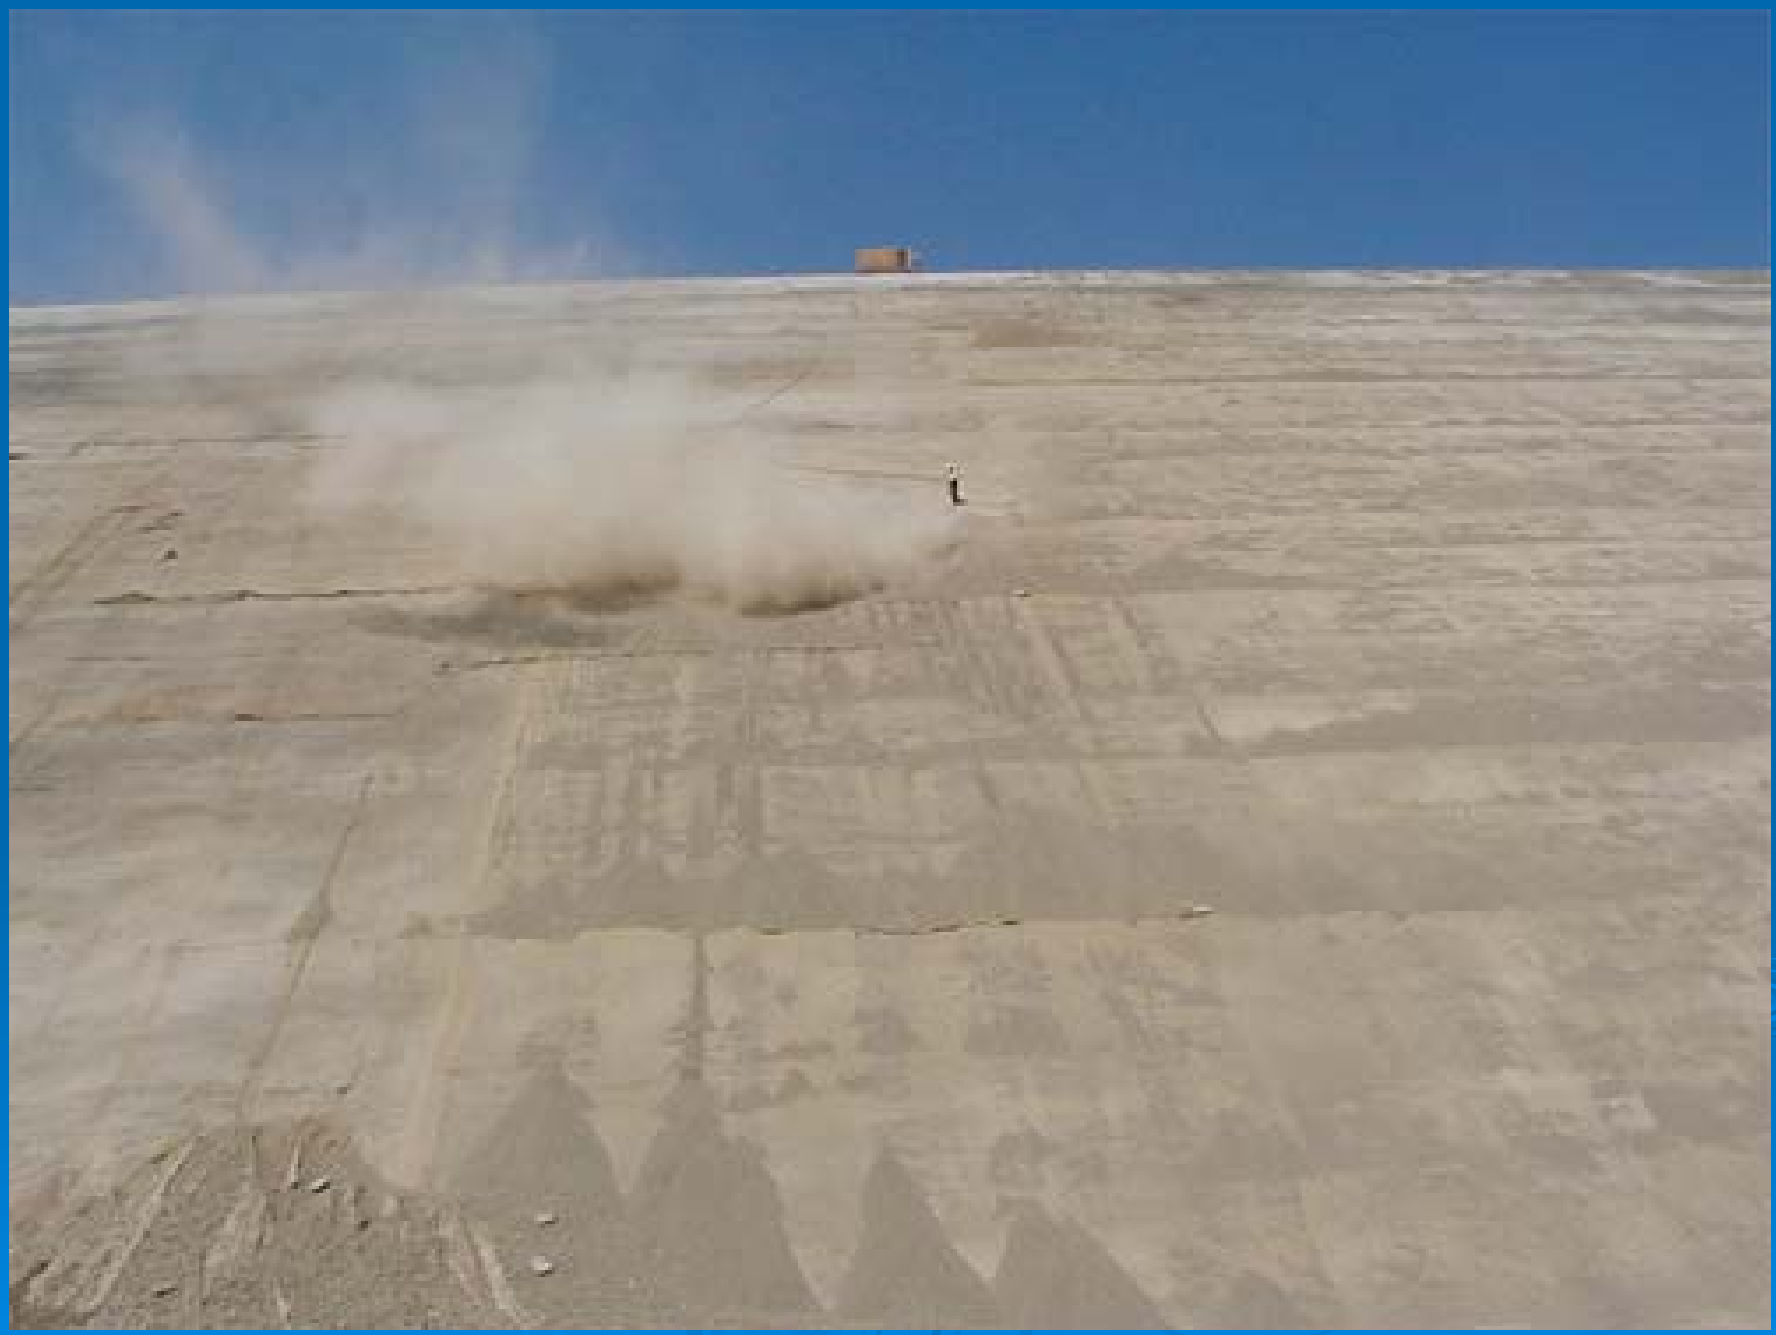
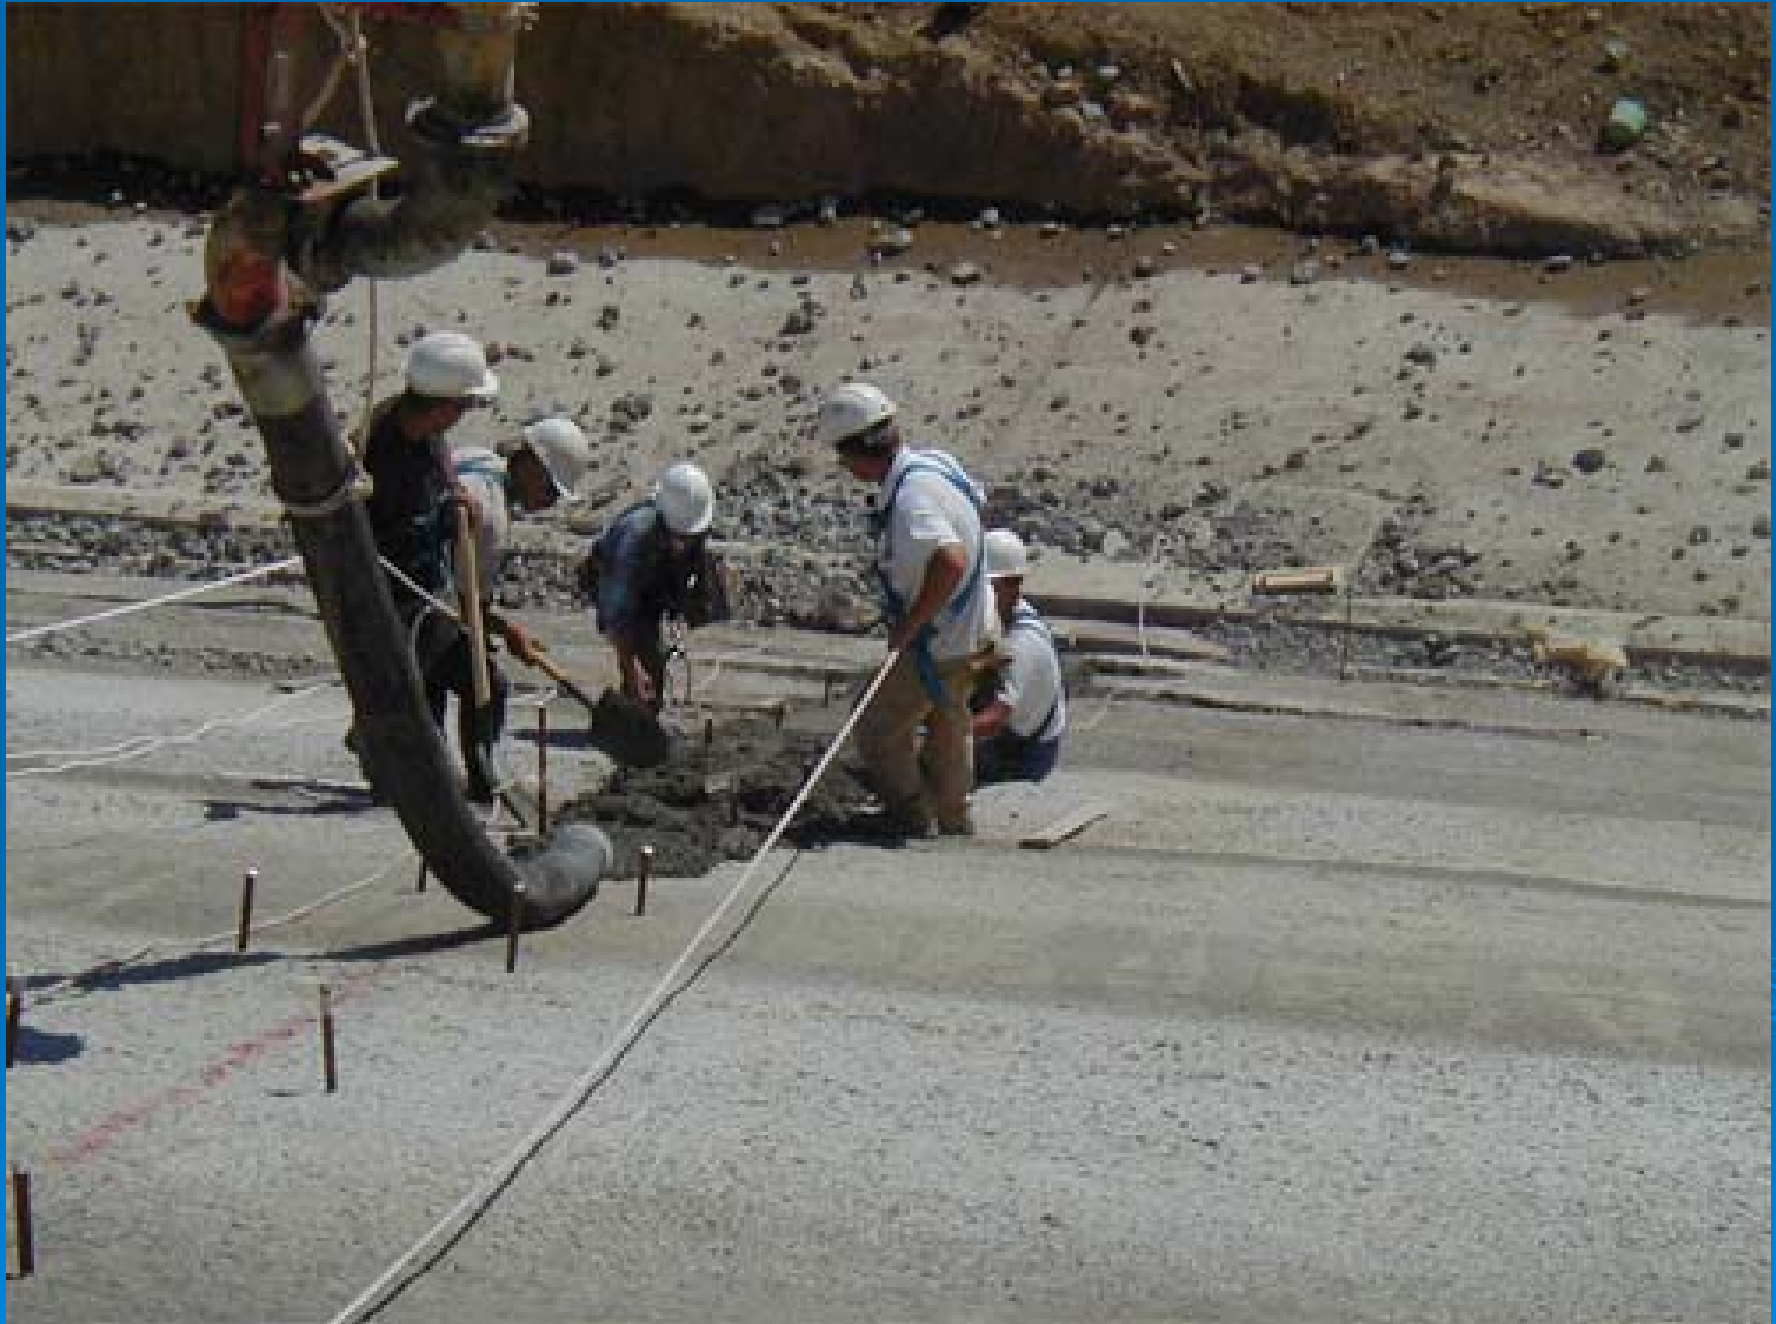
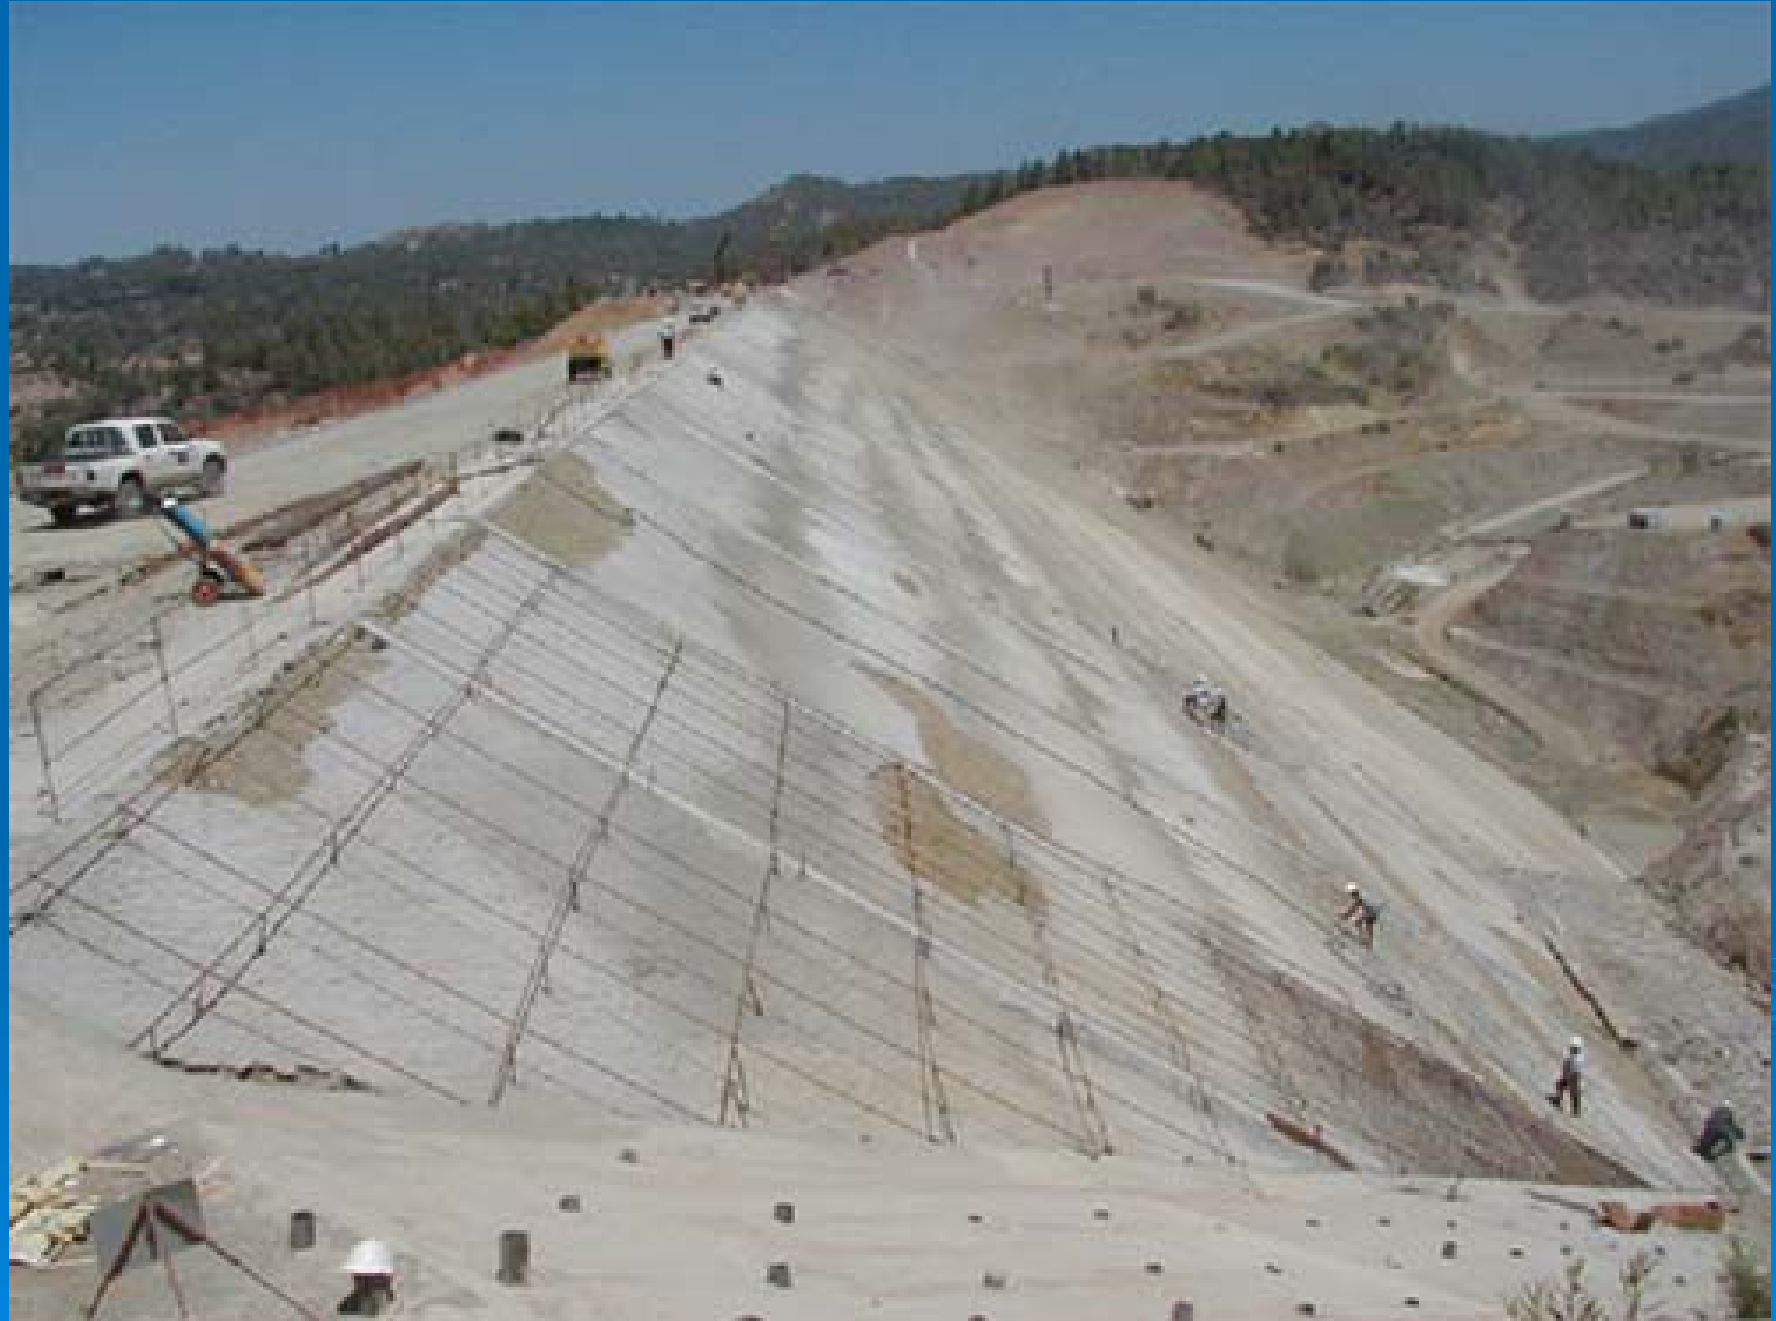
# CONCRETE FACE

- PREPARATION OF FACE
- SURVEY FACE
- DESIGN MORTAR PADS
- TRIM SHOTCRETE
- INSTALL REINFORCEMENT
- COOPER WATERSTOP
- SIDE SHUTTER
- SLIP FORM

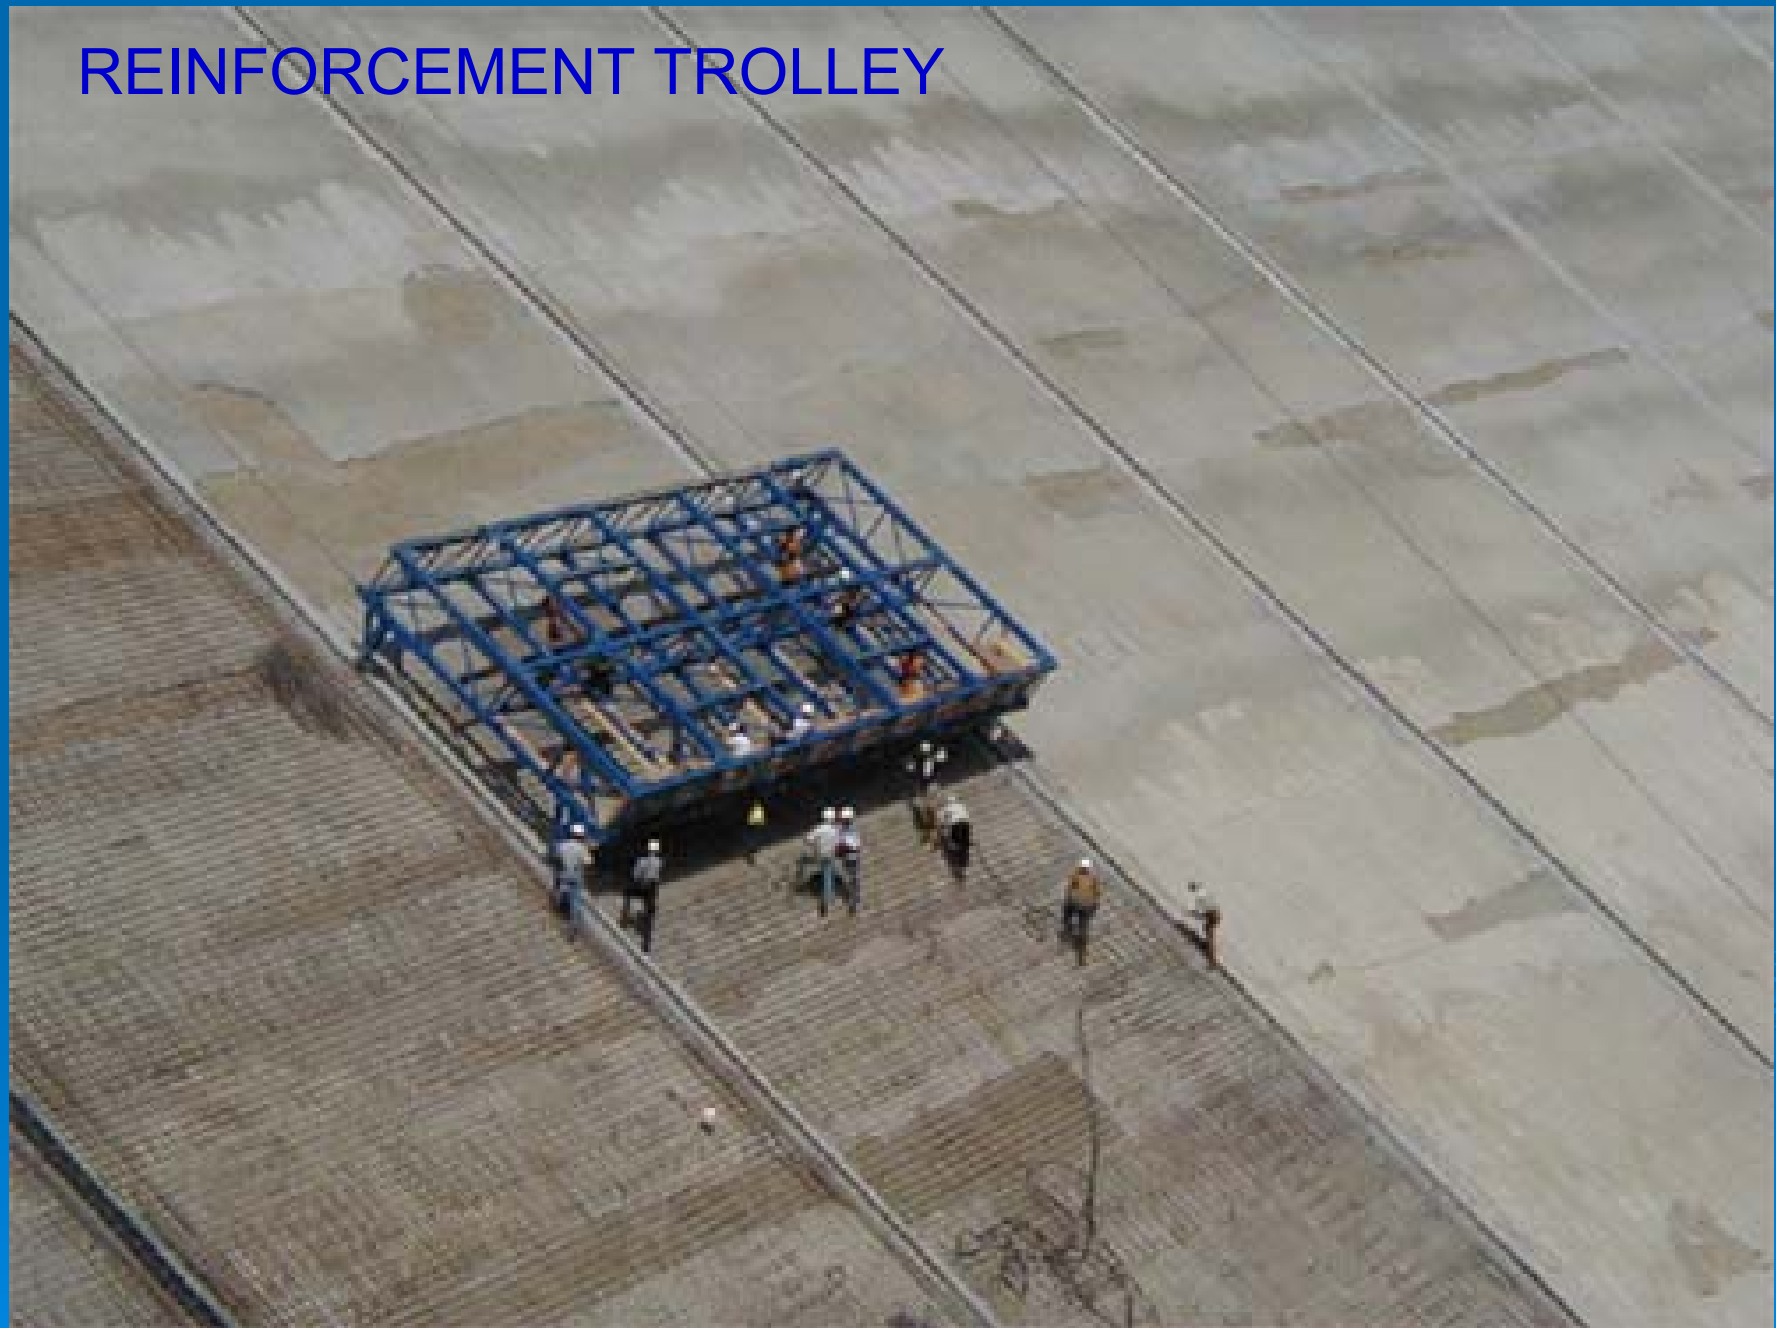
# REINFORCEMENT TROLLEY

- This operation was followed by the reinforcing mats placing team. These were transported down the face with the use of a trolley travelling on two rail lines. The reinforcing mats were placed in the middle of the slab thickness. The work started from the bottom of the bay and progressed up towards the top of the face.

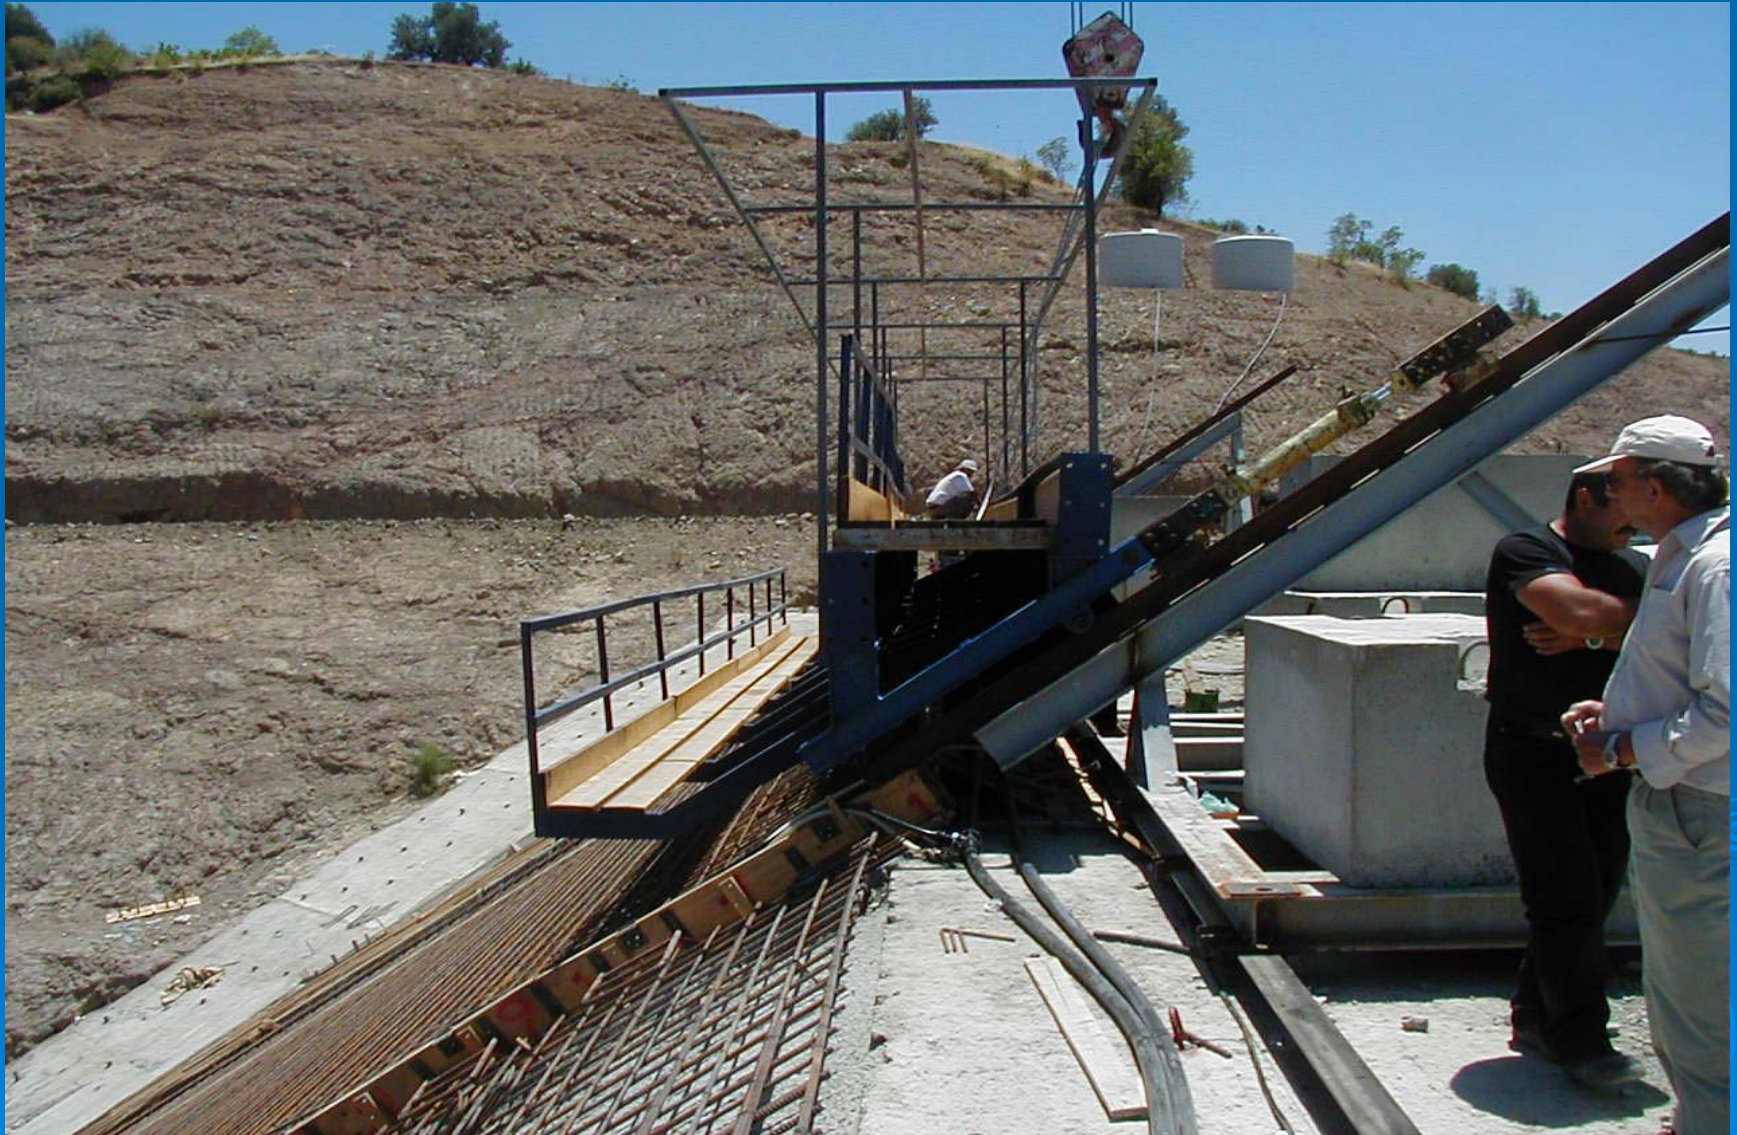
# SLIPFORM TRANSFER TROLLEY AT CREST

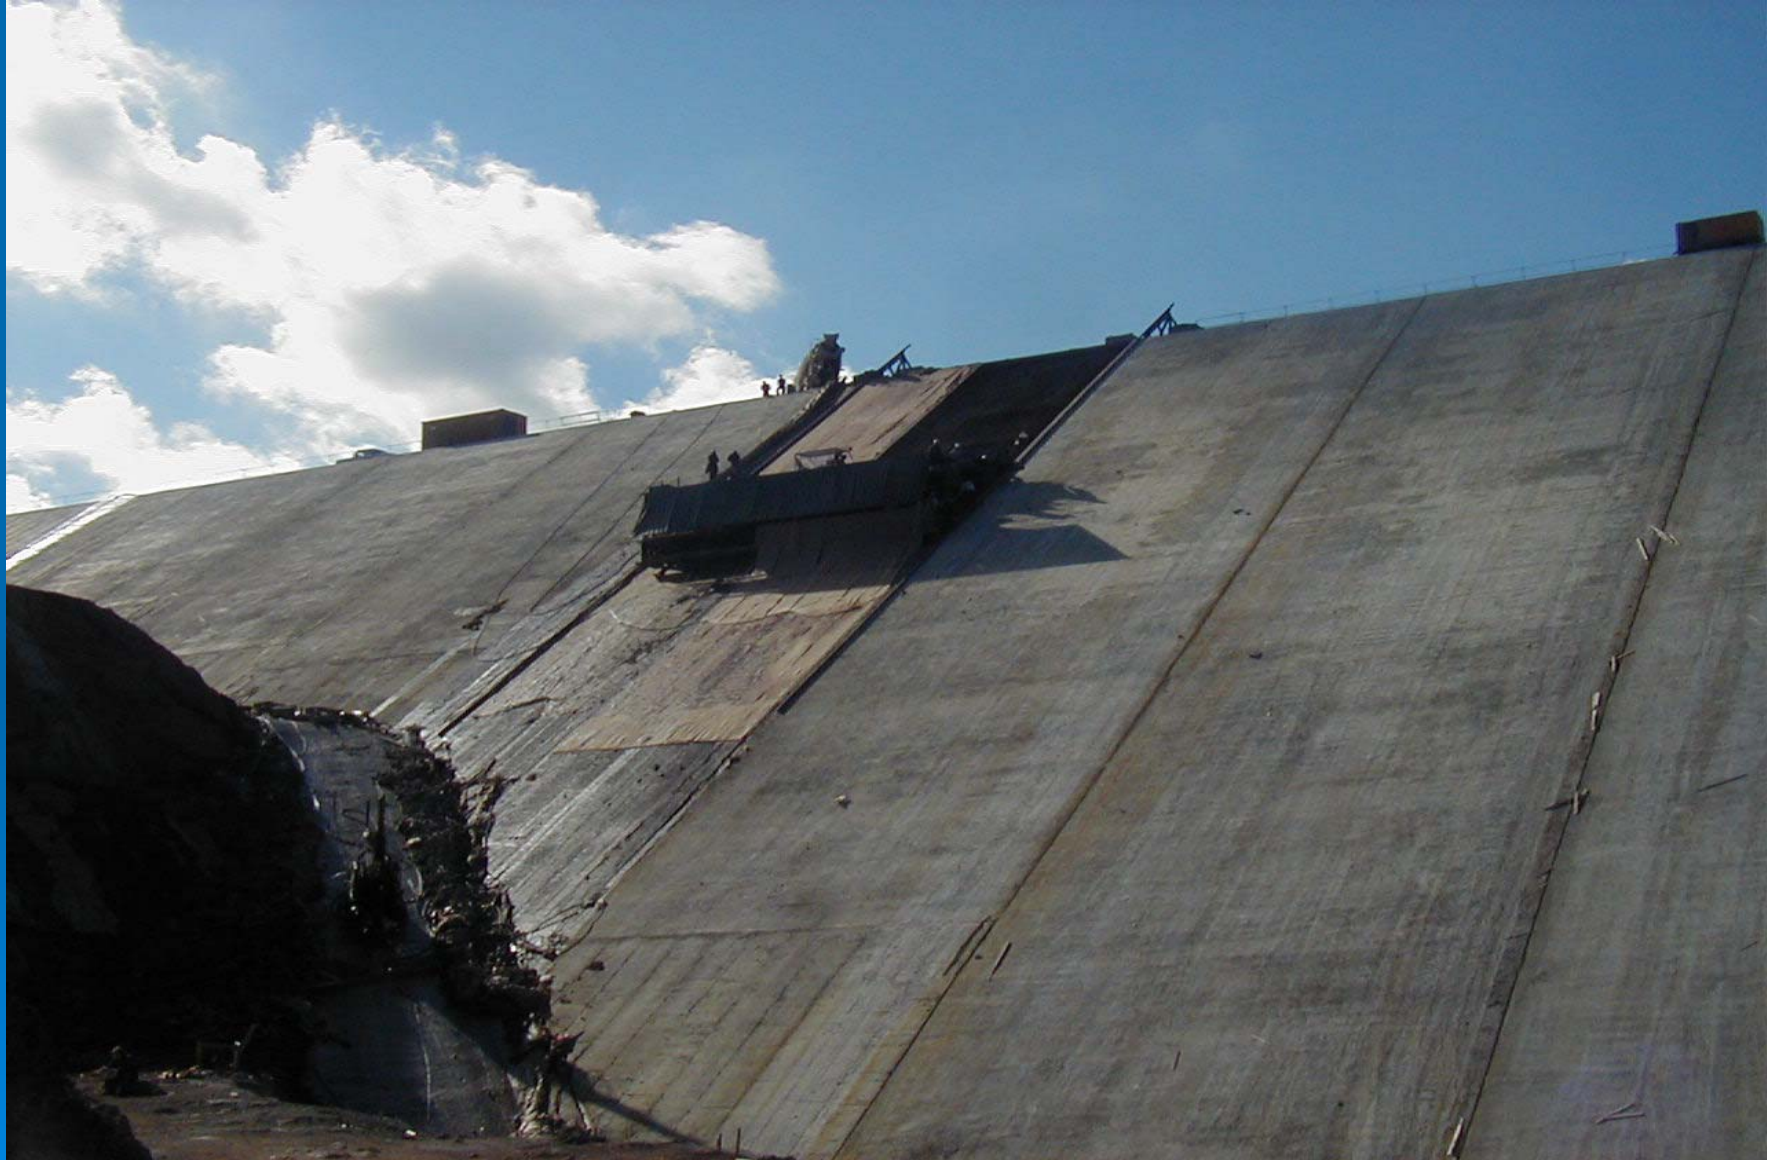
# HALF-BAY SLIPFORMING
