# Innovative methods for the Kannaviou CFRD in Cyprus

## Demos Antoniou

Water Development Department  
Government of Cyprus  
Nicosia  
Cyprus  
E-mail: d.antoniou@cytanet.com.cy

# **KANNAVIYOU DAM THE FIRST CFRD IN CYPRUS**

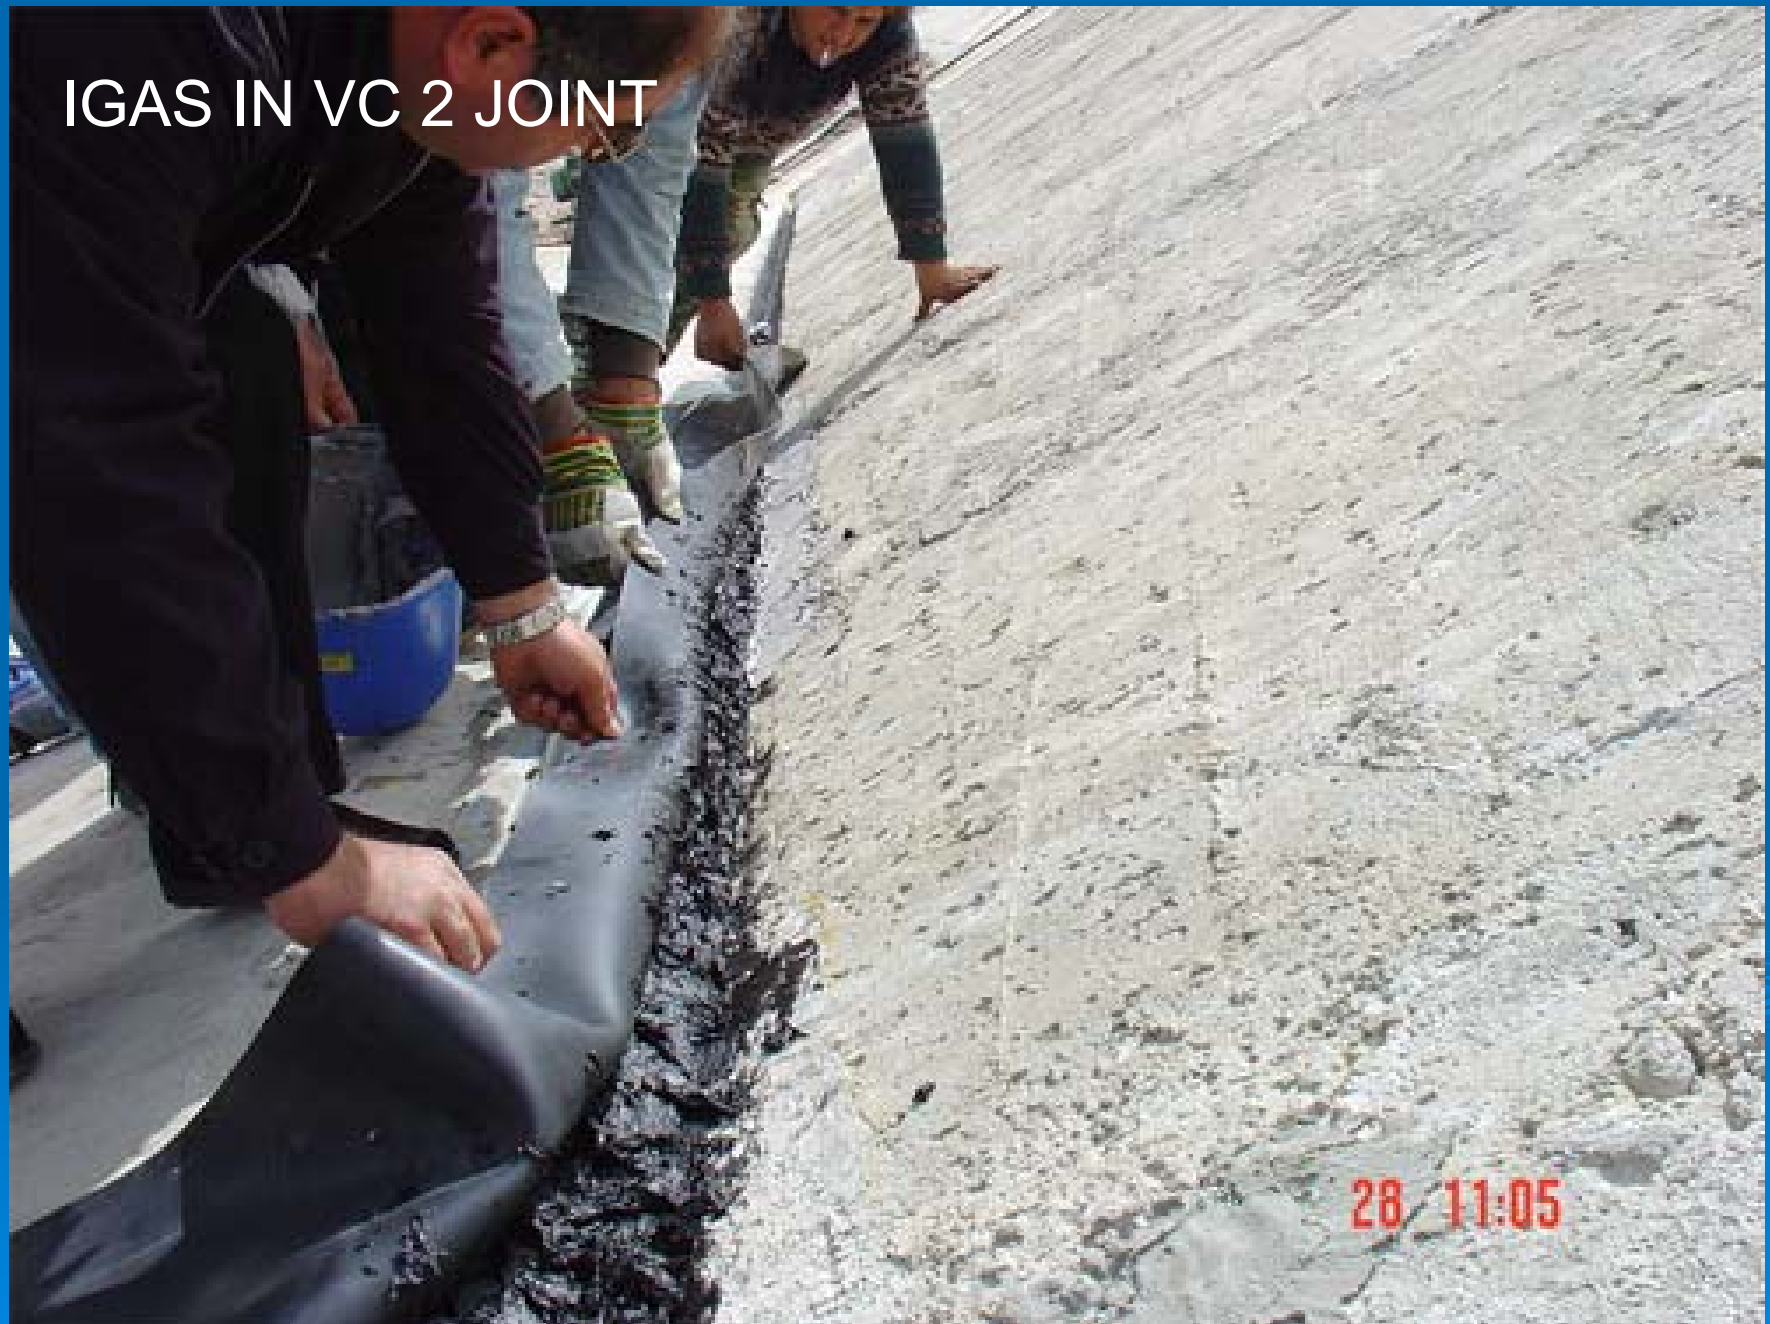
IGAS IN VC 2 JOINT

All the vertical joints and the perimetric joint, which were treated as expansion, were filled with the i-gas material at the top and protected with the hypalon cover. This was secured to the concrete with two GMS plates bolted to the concrete on either side as required by the specified detail.

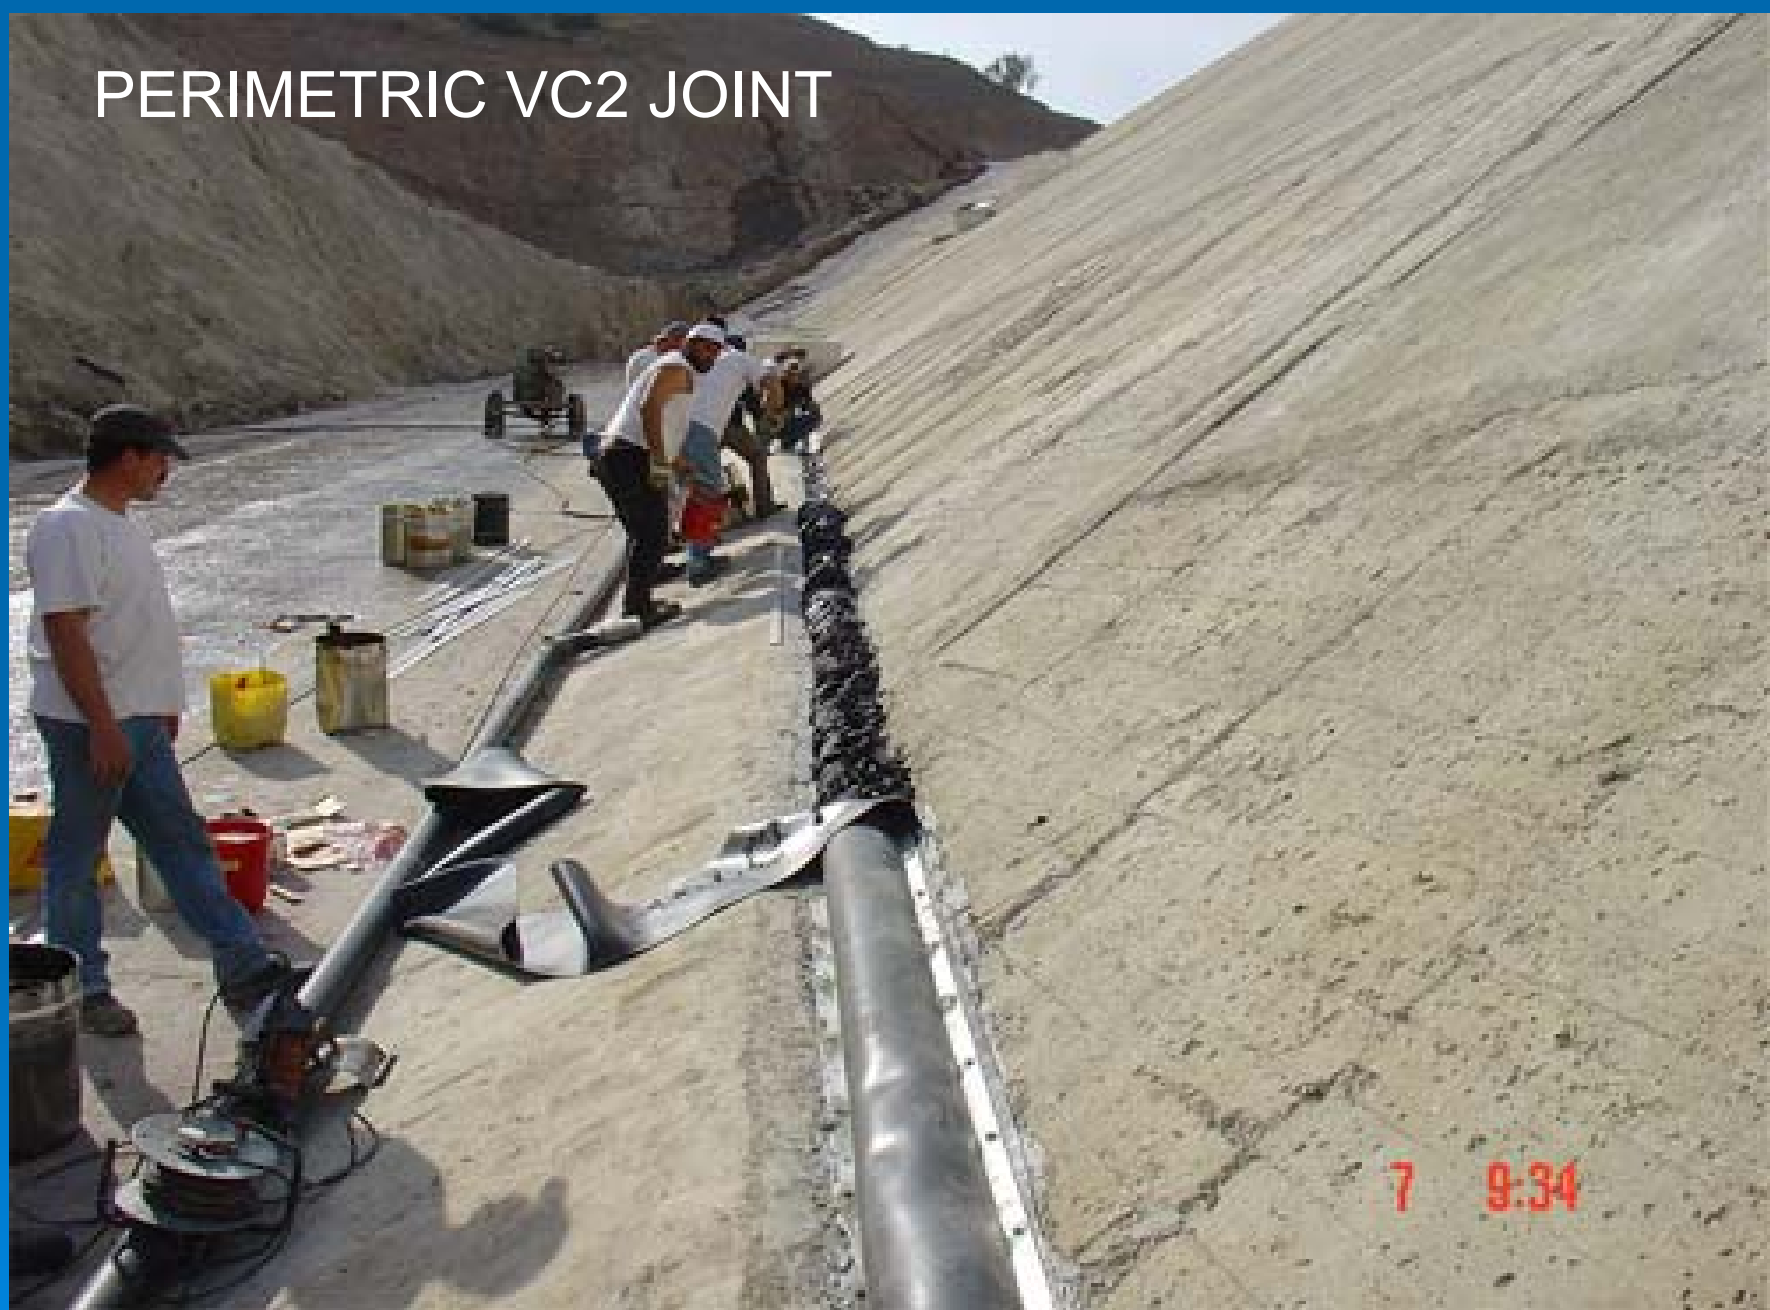
# PERIMETRIC VC2 JOINT

After completion of the slab, the perimetric joint, below the level of 375m.el., was covered with a layer of fine silty sand, whose purpose is to "collapse" and flow into the joint in case the water stop is damaged. Outside the sand a layer of lava material of 3C was placed to protect it from erosion. The original design envisaged backfilling of the two vallies up to the level of 375m.el. with general material 4A. This was later deleted and the area was flooded with water. This enables re-visiting the plinth area for either additional grouting, if needed, or carrying out some work on the joint.

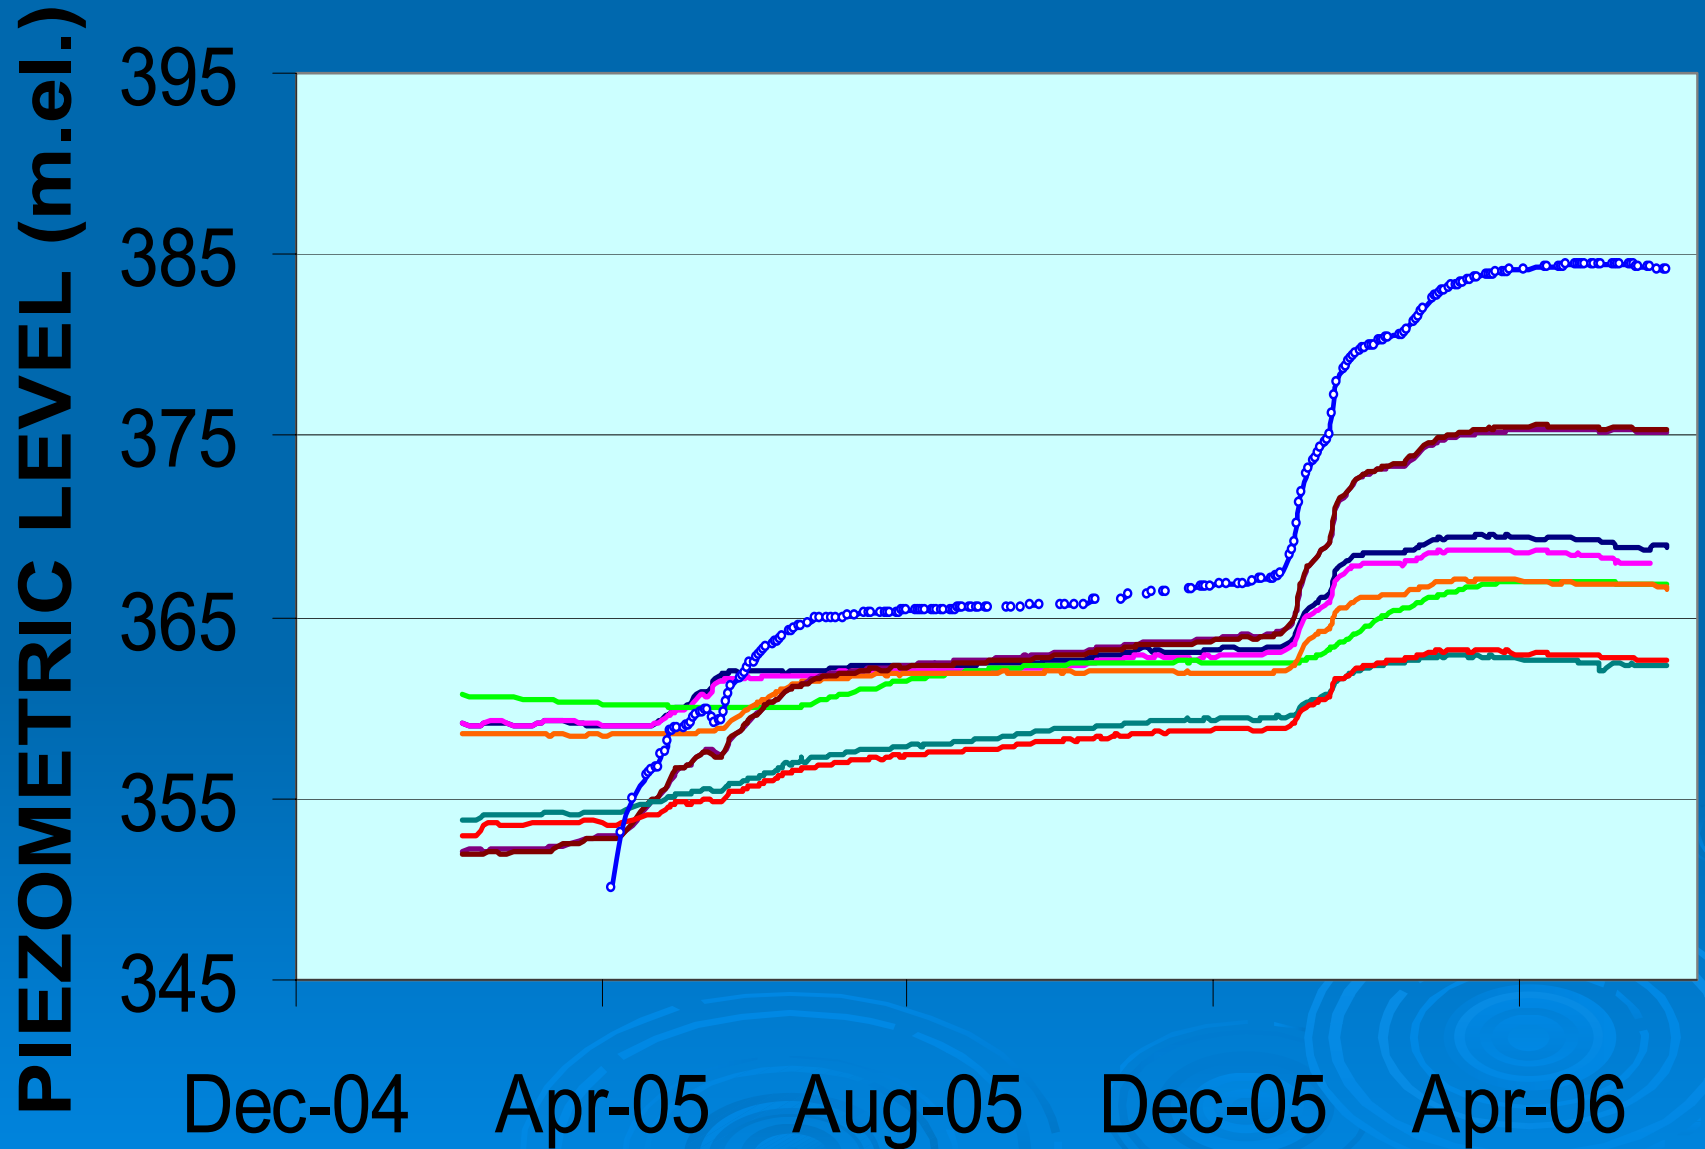
# FOUNDATION PIEZOMETERS

A very close monitoring of the internal pressures within the embankment, was done, to ensure that the drainage system installed at the foundation, draining the lower part of the embankment was functioning properly. Not proper draining could lead to build-up of internal pressures and cause damage to the slab.

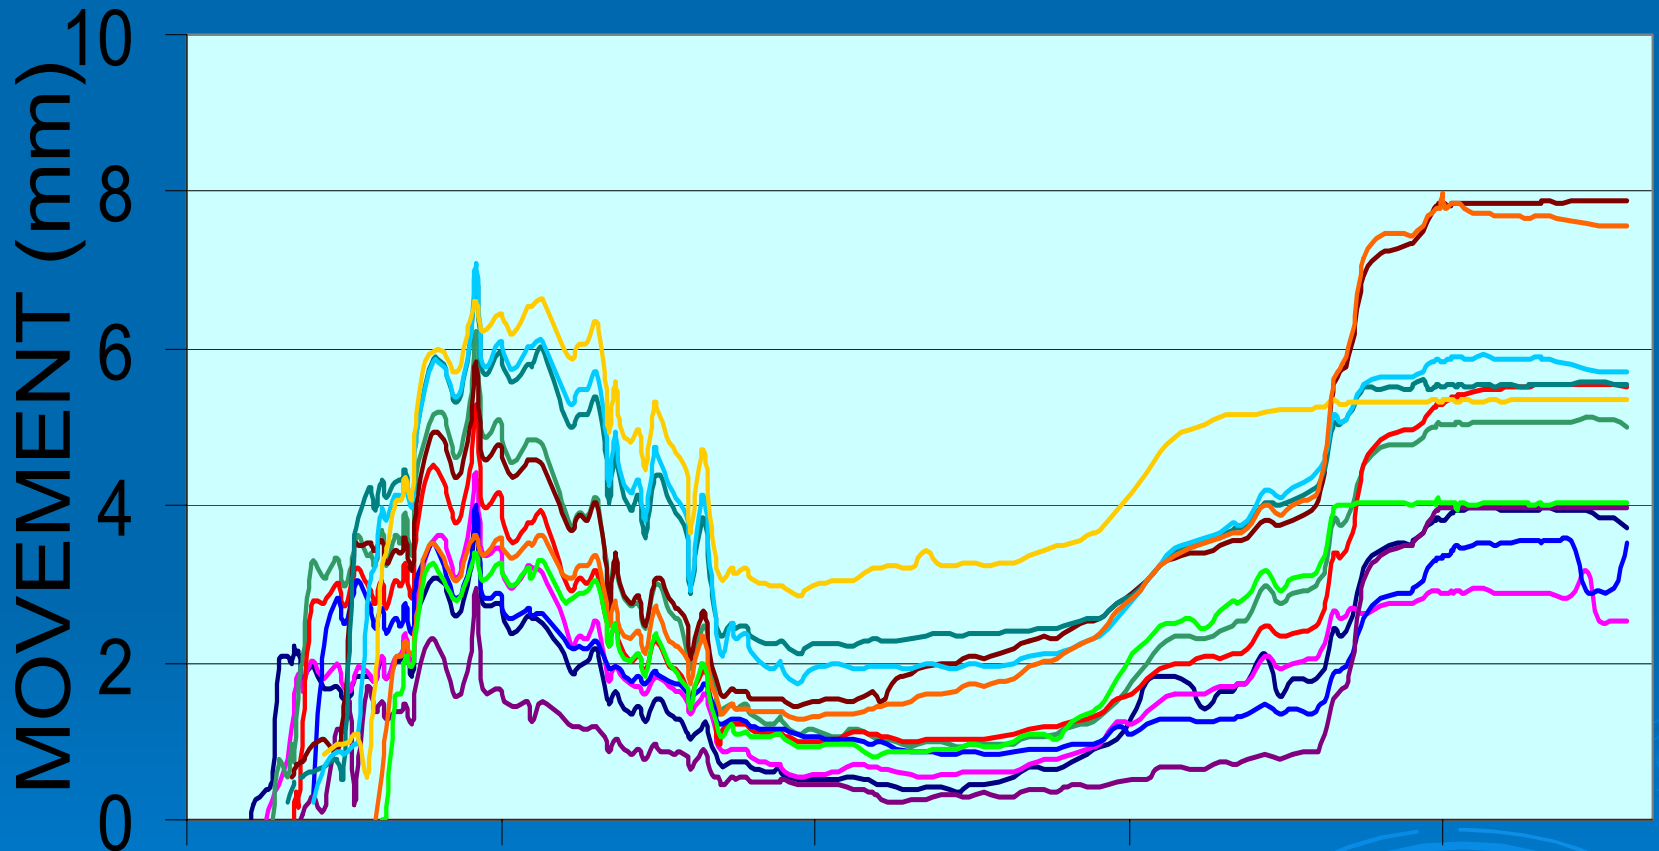
# EMBEDDED PERIMETRIC JOINT METERS

Movement +ve=joint opening

After impounding and following the application of the reservoir loading, the close monitoring of the joint movements, showed that some joints started opening. The measured movements increased up to 7-8 mm, which is well within the expected values. It is also shown that some movement is caused by the temperature seasonal variation effecting the concrete's shrinkage. All the movements measured to the end of June 2006 are shown in Fig 3.

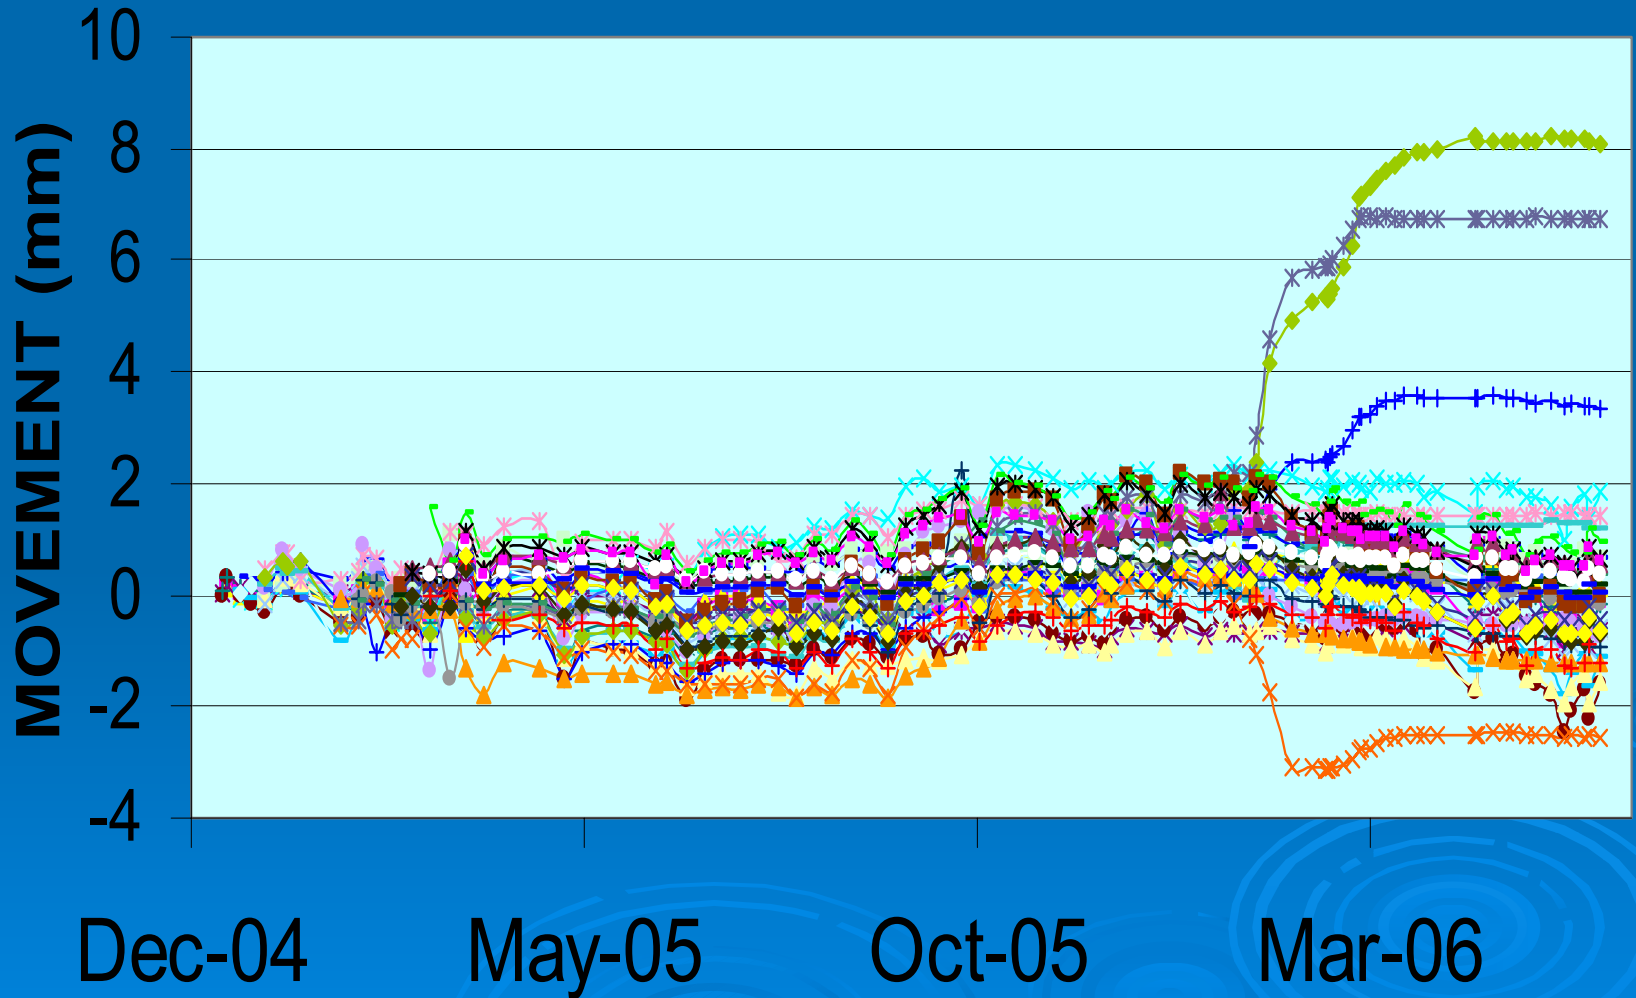
# SURFACE JOINT METERS

+ve= opening

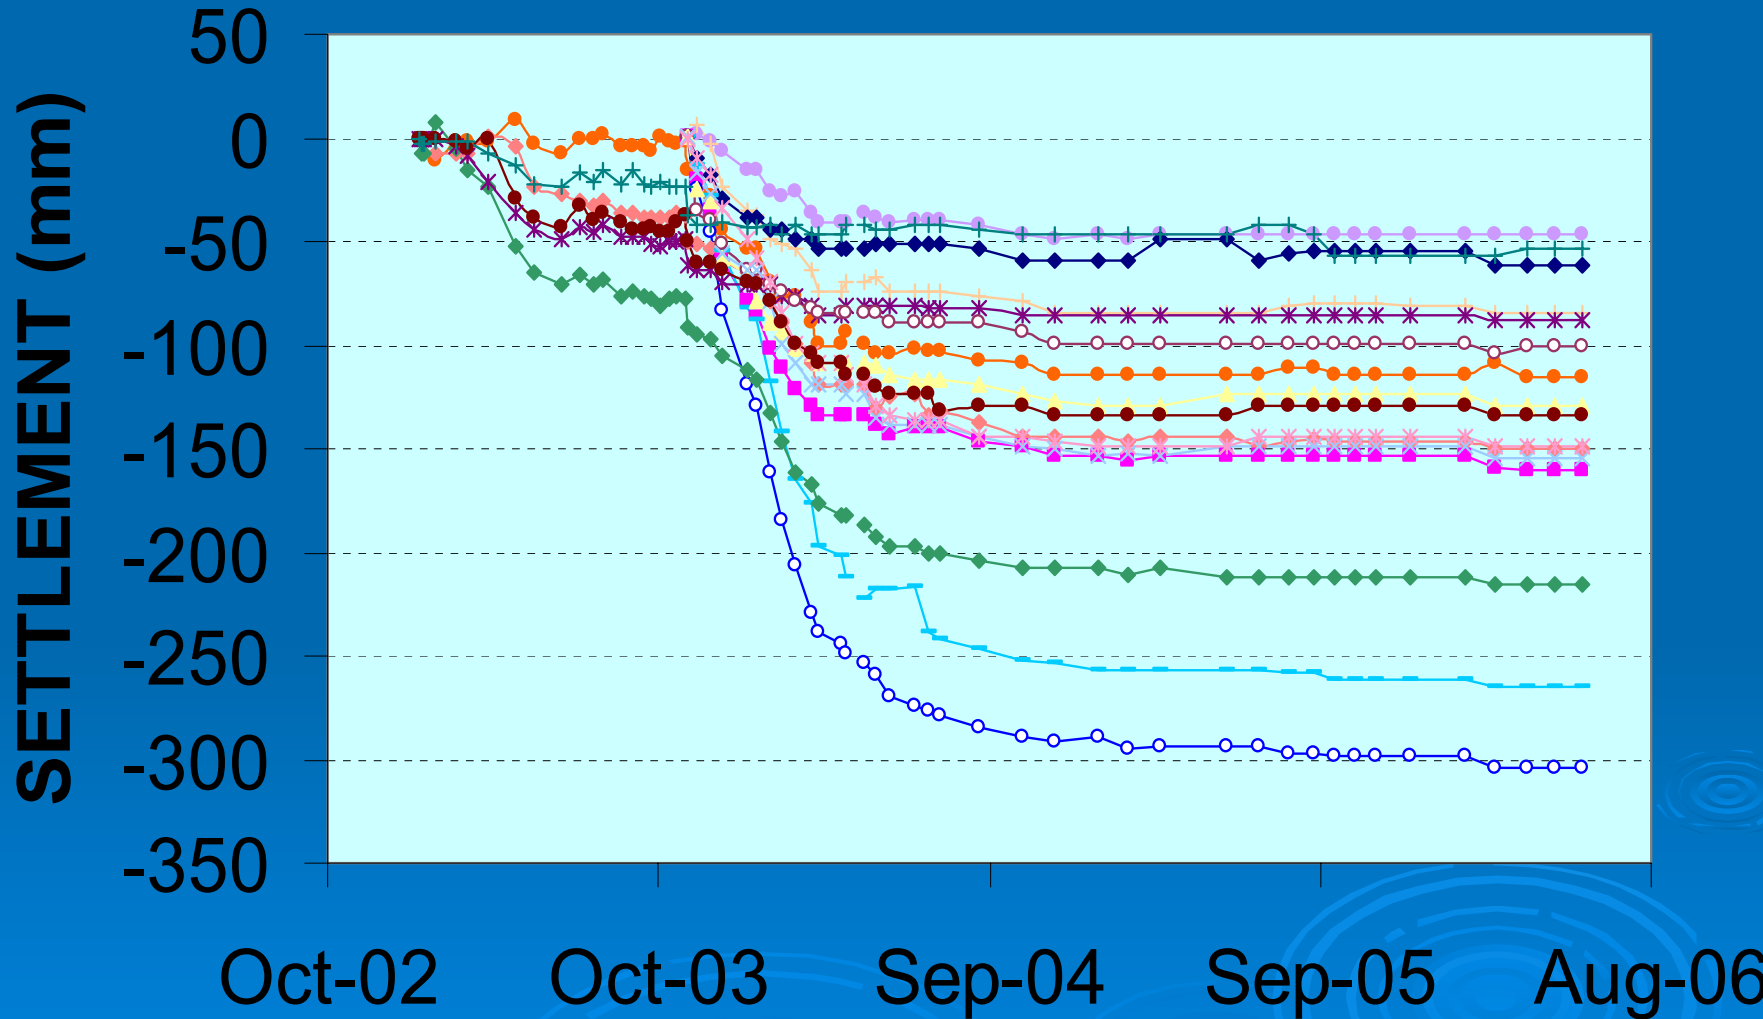
# SETTLEMENT CELLS AT 382 LEVEL

Settlements measured in the upper section (elevation 395m) of the dam during the construction period, show that the maximum recorded values at completion of the embankment were 160 mm in Zone 3B and 200 mm in Zone 3C. The moduli of deformability of Zones 3B and 3C, determined from the measured settlement and the stresses corresponding to the weight of the overlying layers, were 90 MPa and 50 MPa, respectively.
