The Rehabilitation of the Asbestos Mine, Cyprus

Kyriacos Kyrou, Water Development Department, 1413 Nicosia, kyrouk@avacom.net
George Petrides, Geological Survey Department, 1415 Nicosia, gsd@cytanet.com.cy

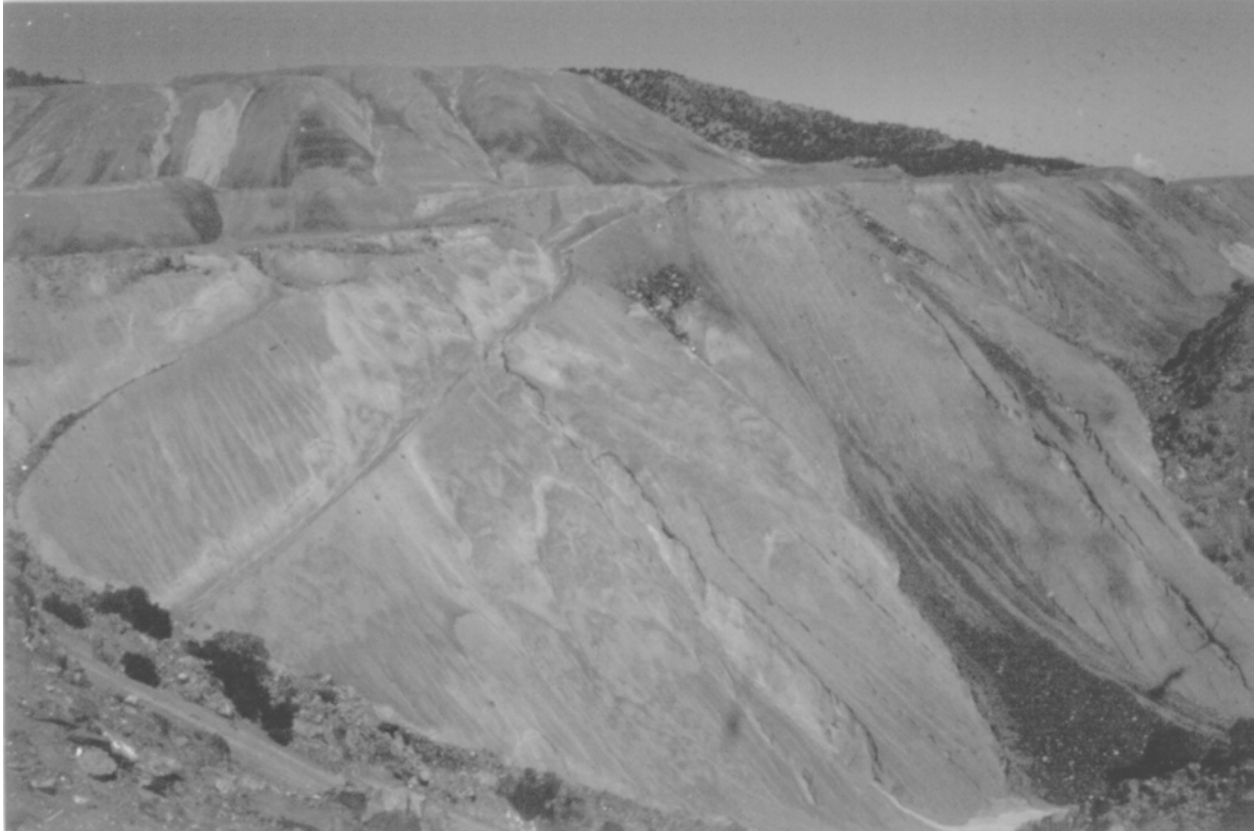
FIGURE 2. Waste tips dumped on steep slopes and side valleys.

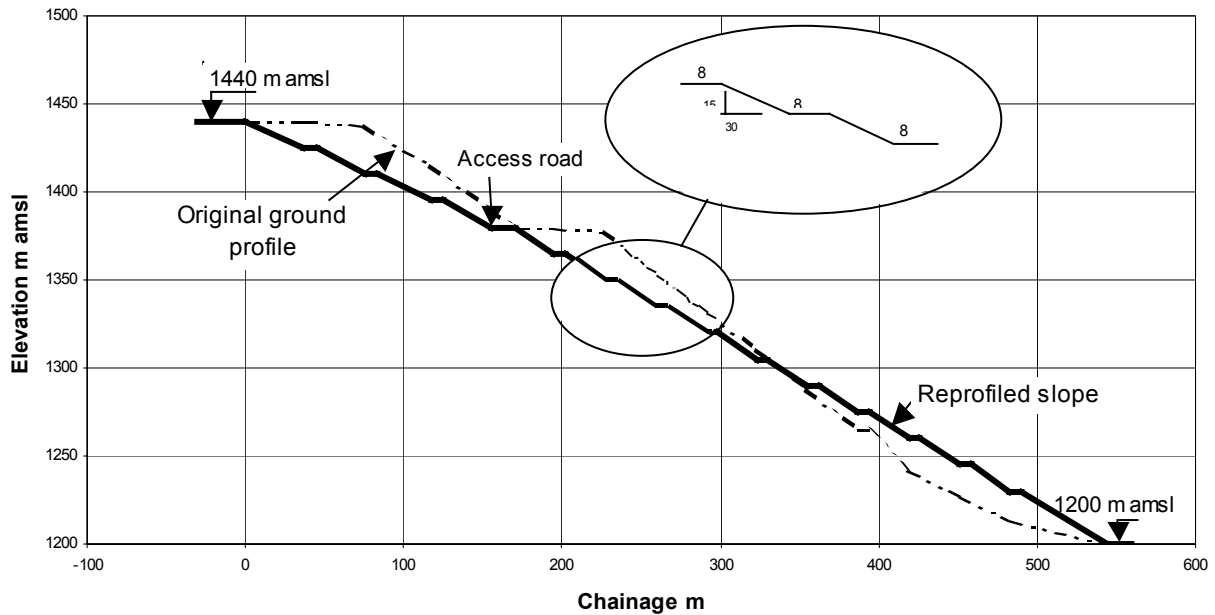
FIGURE 3. Typical profile adopted and implemented at Loumata valley tips.

the alkaline nature of the wastes, which prevents the grow of any form of vegetation, it became apparent that access to lorries would be essential on the new slopes for the transportation of fertile soil, planting and irrigation. Following consultations with the experts of the Forestry Department it was decided that the maximum slope that would facilitate the grow of vegetation would be 2 horizontal : 1 vertical. In addition berms 8 m wide at 15 m elevation intervals, would be required for the planting of trees. A typical profile adopted and implemented at the Loumata valley tips is shown in fig. 3. This slope is the highest man made slope in Cyprus with a total height in excess of 240 m.

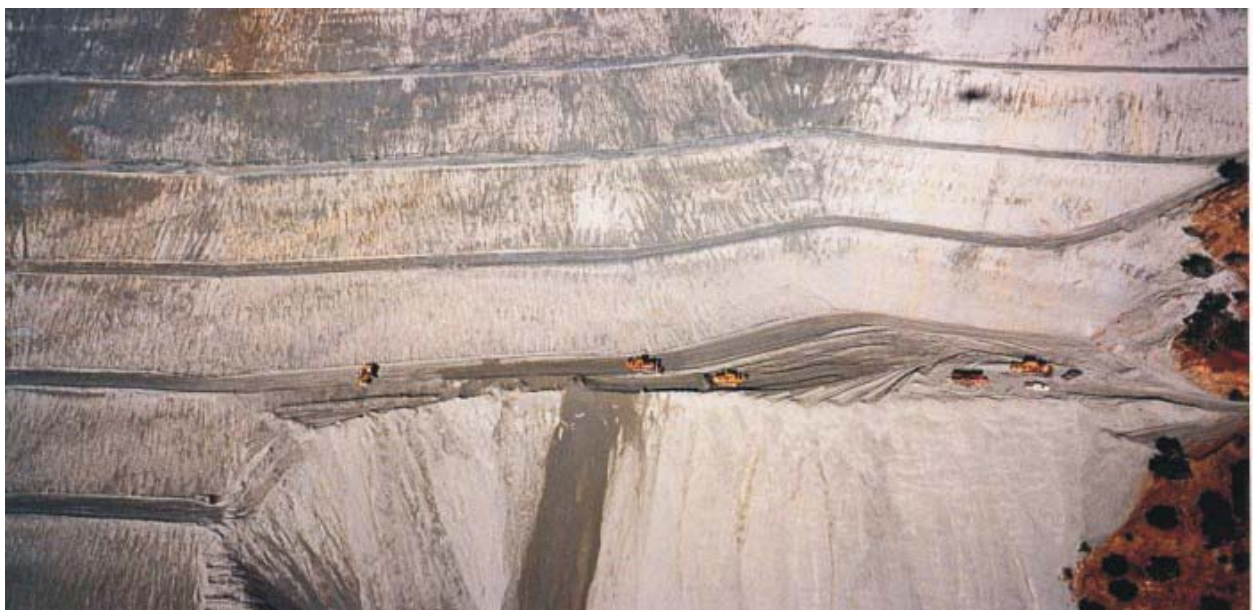
FIGURE 5. Stabilization of the Loumata valley tips.

Due to budgetary and other practical reasons but also due to initial lack of confidence in achieving the required result it was decided to perform the work under medium size contracts addressed mainly to medium size earthworks contractors who traditionally offer more competitive prices. Seven contracts have been completed till now, representing about 70% of the total earthwork. The location of these contracts is shown diagrammatically in fig. 4. The first two contracts carried out for the stabilization of the new tip involved the removal and placement of some 1.8 million cubic metres of waste material (see fig. 5 & 6). The third contract involved the reprofiling of some 450.000 m³ of material in the old tip area.

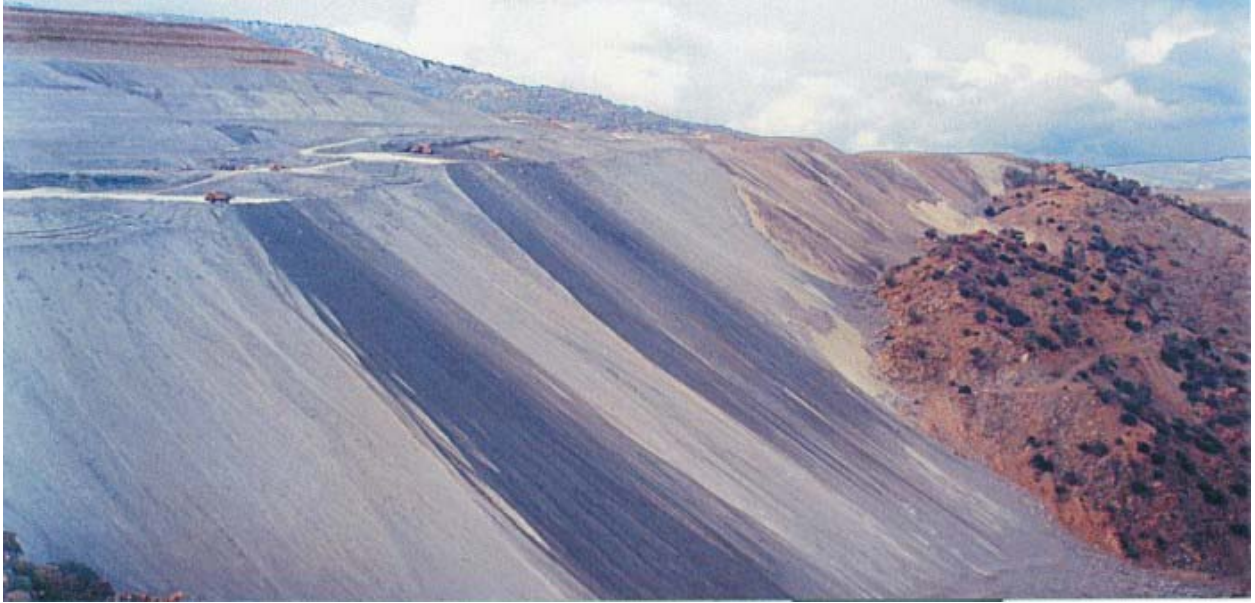
FIGURE 6. Stabilization of the Loumata valley tips.

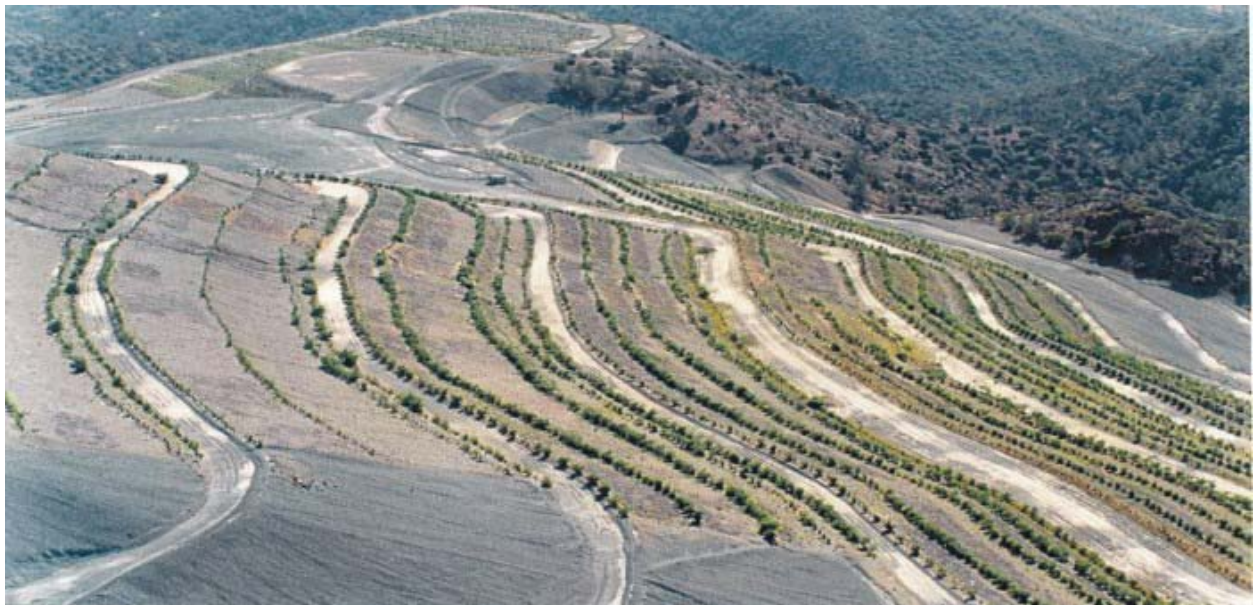
FIGURE 7. Slopes after reforestation

Traditional thatching is used for protecting seeds sown on sloped ground from being washed away by rainwater. Ground preparation works are carried out all the year round. Sowing is done from the beginning of September together with thatching. Planting is effected from early October through December. It is estimated that the cost of reforestation of one hectare is around 15000 Cyprus pounds (25000 Euros). The whole reforestation and revegetation effort has so far been proved extremely successful and the encouraging results are already obvious (see fig. 7 & 8).

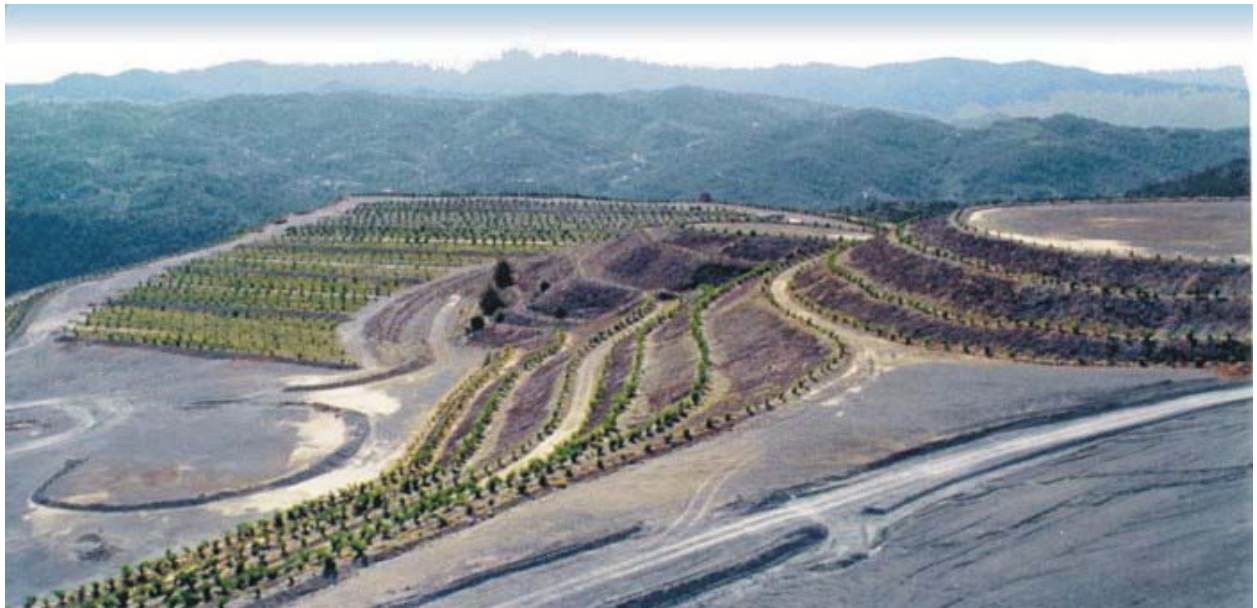
FIGURE 8. Asbestos Mine, the new look.
