The first 30 years of Lefkara Dam

K. Kyrrou MSc, PhD, CEng, MICE, A. Penman DSc, CEng, FICE and C. Artemis MSc, DIC, CEng, MICE

The 74 m high Lefkara embankment dam was built in the early 1970s for the Republic of Cyprus Water Development Department in order to supply domestic water to the cities of Famagusta and Larnaca. It is a rockfill dam with a central clay core composed of a combination of residual soils and colluvium supported by diabase rockfill shoulders. The dam was well instrumented using total pressure cells, piezometers and internal settlement gauges as well as surface settlement markers. These instruments are still working and the results are discussed in the paper. The dam is curved in plan since it was anticipated at the time of its design that the arched plan would help resist the thrust from the reservoir, but in reality it made virtually no difference to the behaviour that would be expected from a straight dam. Instead of the conventional vertical valve shaft for housing the water intakes at various levels, a semi-buried inclined gallery (shaft) has been adopted. Leakages of reservoir water through the gallery joints into the gallery have been creating problems

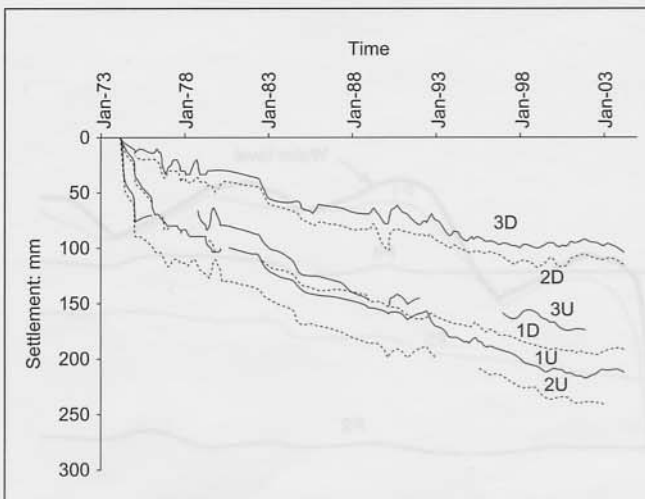
Fig. 6. Development of post construction settlements of six surface settlement markers (line B)

Post-construction surface settlements have been monitored by recording the settlements of surface settlement markers installed along lines A, B and C using high-precision survey equipment to relate their movements to stable reference datum positions on rock outcrops away from the dam. The markers were installed in February and March 1974, two to three months after completion of the embankment. They have now (2004) recorded maximum post-construction settlements of the order of 245 mm on the maximum section. The development of post-construction settlements from six surface settlement markers (three upstream and three downstream of the dam centreline) on section B is shown in Fig. 6. These settlements were found to have an obvious degree of dependency on the depth of fill below, although it needs to be pointed out that due to the effect of saturation of the rockfill, settlements on the upstream shoulder were greater than on the downstream

shoulder, as demonstrated by the plot of depth of fill against settlement in Fig. 7. A comparison of the internal settlements recorded by the hydraulic overflow cells and the surface settlements on line B clearly demonstrates that post-construction compression of the upper half of the embankment represents more than 60% of the post-construction compression of the entire embankment.

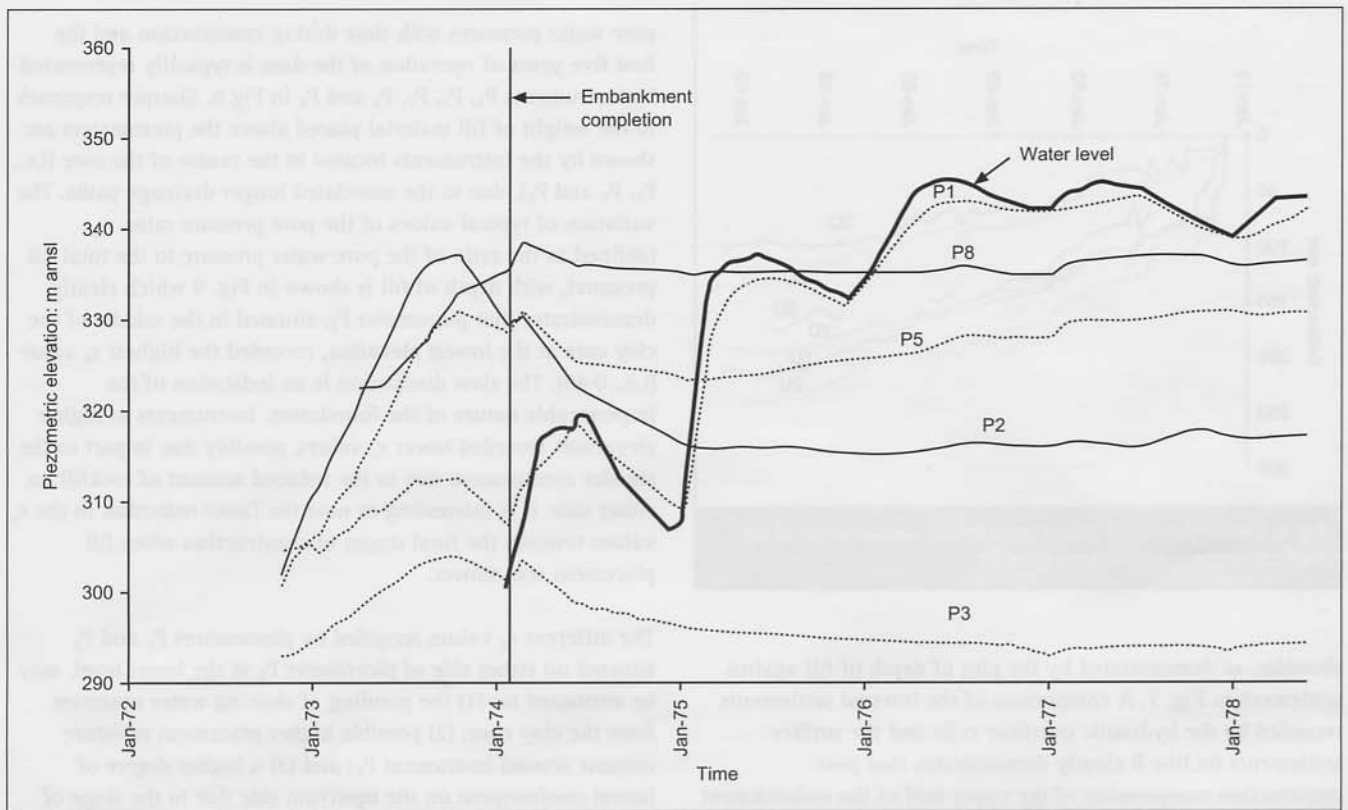
Fig. 8. Variation of pore water pressure during construction and during the first five years of operation (amsl, above mean sea level)

pore water pressures with time during construction and the first five years of operation of the dam is typically represented by instruments P_1 , P_2 , P_3 , P_5 and P_8 in Fig 8. Sharper responses to the weight of fill material placed above the piezometers are shown by the instruments located in the centre of the core (i.e., P_2 , P_5 and P_8), due to the associated longer drainage paths. The variation of typical values of the pore pressure ratio, r_u (defined as the ratio of the pore water pressure to the total fill pressure), with depth of fill is shown in Fig. 9 which clearly demonstrates that piezometer P_2 , situated in the middle of the clay core at the lowest elevation, recorded the highest r_u value (i.e., 0.40). The slow dissipation is an indication of the impermeable nature of the foundation. Instruments at higher elevations recorded lower r_u values, possibly due in part to the smaller confinement due to the reduced amount of rockfill on either side. It is interesting to note the faster reduction in the r_u values towards the final stages of construction when fill placement was slower.

The different r_u values recorded by piezometers P_1 and P_3 situated on either side of piezometer P_2 at the lower level, may be attributed to: (1) the ponding of sluicing water upstream from the clay core; (2) possible higher placement moisture content around instrument P_1 ; and (3) a higher degree of lateral confinement on the upstream side due to the slope of the rock foundation. After placement of the rockfill and filters, the clay may have been prevented from moving laterally in an upstream direction due to the rock foundation, which is sloping towards the clay core. On the downstream side, the slope is away from the clay core giving the core a better chance to expand downstream when compacted. The piezometric elevations recorded by the same instruments during the last 15 years are shown in Fig. 10 and they clearly represent the pore water pressures due to the transient conditions of seepage.

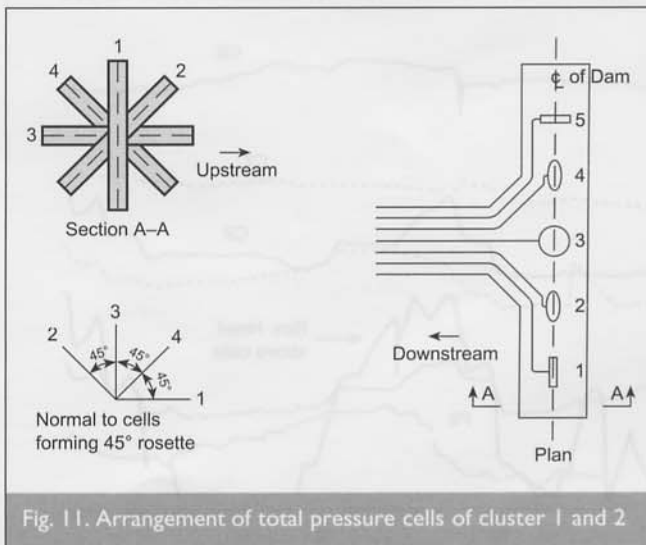
Fig. 11. Arrangement of total pressure cells of cluster 1 and 2

In cluster 1 installed at an elevation of 306 m amsl, the highest average pressure is recorded by the horizontal cell (no. 3), followed by the two cells installed at 45° (nos 2 and 4) and then by the vertical cell measuring horizontal pressures in an upstream-downstream direction. The lowest pressures were recorded in a direction along the dam axis (no. 1). Considerable differences have been recorded by the two diaphragms of each cell. These different pressures can be expressed as percentages of the higher measured pressure and these were typically of the order of 4%, 8%, 28%, 38% and 15% for cells 1 to 5, respectively. The horizontal cell (no. 3) and the two inclined cells (nos 2 and 4) have consistently been recording higher pressures on the upper diaphragm. This may be due to the better contact of the fill against the diaphragm which was placed against it, as distinct from the bedding of the lower diaphragm against a prepared surface of the fill that was scraped to be as flat as possible. Although readings are being recorded by all five cells in cluster 1, it was noted that in 1988 the lower diaphragm of cell 3 ceased to record any pressures. Since then only the pressure recorded from the upper diaphragm is being presented and this is indicated by a kink to a higher pressure on the time plot (Fig. 12). The upper diaphragm of cell 2 similarly ceased to operate in February 2003 (more than 30 years after installation) and since then only pressures from the lower diaphragm are presented.

to be 1150 kN/m^2 . The average pressure recorded by cell 3 up until 1988 was slightly below this value but the pressures from the upper diaphragm presented thereafter are between 16% and 21% higher than the overburden. Assuming this value is an overestimate and by applying a cell action factor of 1.09 as suggested by Buck,² the corrected pressure given by Fig. 12 is between 8% and 13% higher than the overburden. Because of the expected and measured greater settlement of the core, some transfer of loading from the core to the rockfill shoulders was expected, so that it was concluded that the pressure recorded is in fact an overestimate. On the other hand, there is no need to expect the total pressure to exactly reflect the height of overburden above a particular point in

Regarding the possibility of hydraulic fracture in the clay core,^{5,6} it is noted that the pore water pressures recorded by piezometer P₅, installed adjacent to the cluster of total pressure cells, has always been below any of the corresponding total pressures recorded, hence effective stresses in all directions are positive.

The behaviour of cluster 2 was to a certain extent similar to cluster 1. Pressures in a vertical direction at the horizontal cell (no. 8) were the highest, with next lower pressures measured by the two inclined cells (nos 7 and 9). The order of stresses recorded by the vertical cells 6 and 10 was different however, with the horizontal stresses in the direction of the dam axis (no. 10) being higher than those normal to it (no. 6). Evidence of this higher horizontal pressure along the dam axis with its associated compression strains has been observed by arching of kerbing stones at crest level as shown by Fig. 14. As in the case of cluster 1 there were differences between the two diaphragms of the cells, which were typically of the order of 8%, 9%, 18%, 45% and 6% of the higher measured pressures for cells 6 to 10, respectively. Similar to cluster 1, the upper diaphragms also record higher pressures than the lower ones. It is noted that one of the diaphragms of cell 6 ceased to operate in 1995 so the pressure presented thereafter is that recorded by the remaining diaphragm.
